Sludge Disposal Site in Rarotonga
Environmental Impact Assessment

Prepared for
To Tatou Vai Limited
Prepared by
Tonkin & Taylor International Ltd
Date
July 2021
Job Number
1013086

Title: Sludge Disposal Site in Rarotonga – Environmental Impact Assessment					
Date	Version	Description	Prepared by:	Reviewed by:	Authorised by:
7.07.21	V1	Draft for TTV discussion	A Gifford	J Carvill	C Freer
12.08.21	V2	Final	A Gifford, C Purchas	C Freer	C Freer

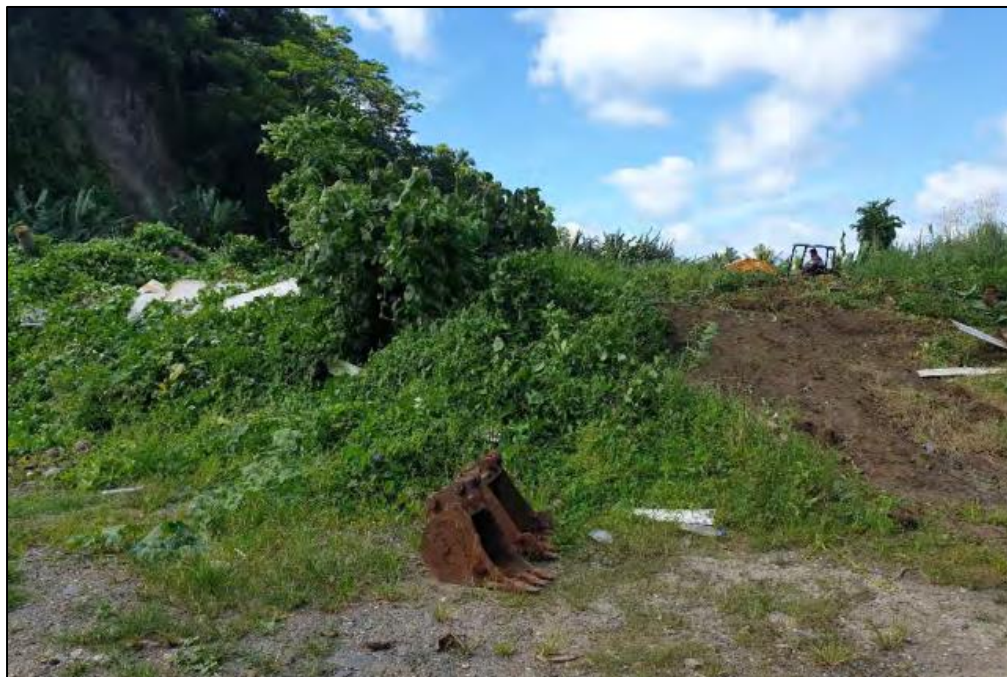
Figure 4.4: Site 88H fill platform

GHD Limited undertook intrusive field investigations of the site (refer to Appendix B). They found that the site has been filled to a depth of approximately 3 m above natural ground level to form a 'platform' (refer to Figure 4.4). The test pits encountered metal of various origins, glass, cans, plastics, fabric, timbers and logs and tires. The fill is mostly mixed with a matrix of sandy partly organic friable soil, and it was assumed that this is the natural soil from the area. Overall, the fill material appears permeable and should readily drain.

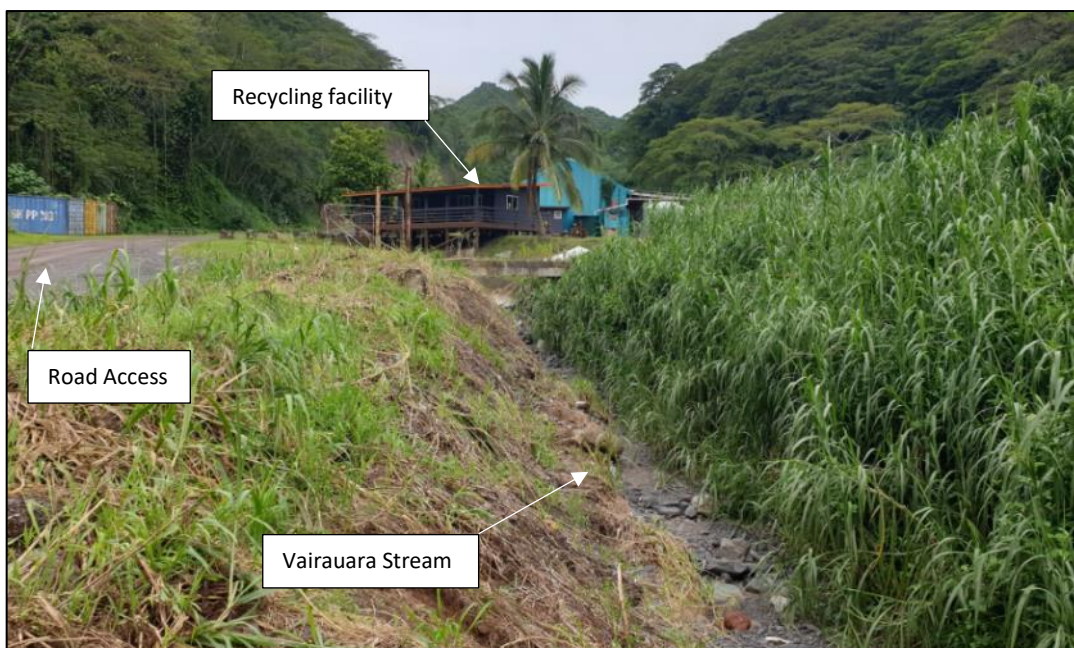
Figure 4.6: Vairauara Stream in the vicinity of the sludge disposal site

- The stream was mostly dry, with two puddles of water present between the recycling facility and the downstream culvert underneath Vairauara Road (refer to Figure 4.6).
- The stream had a slim flow approximately 50 m downstream of the culvert and disappeared into the ground approximately 100 m downstream of the culvert.

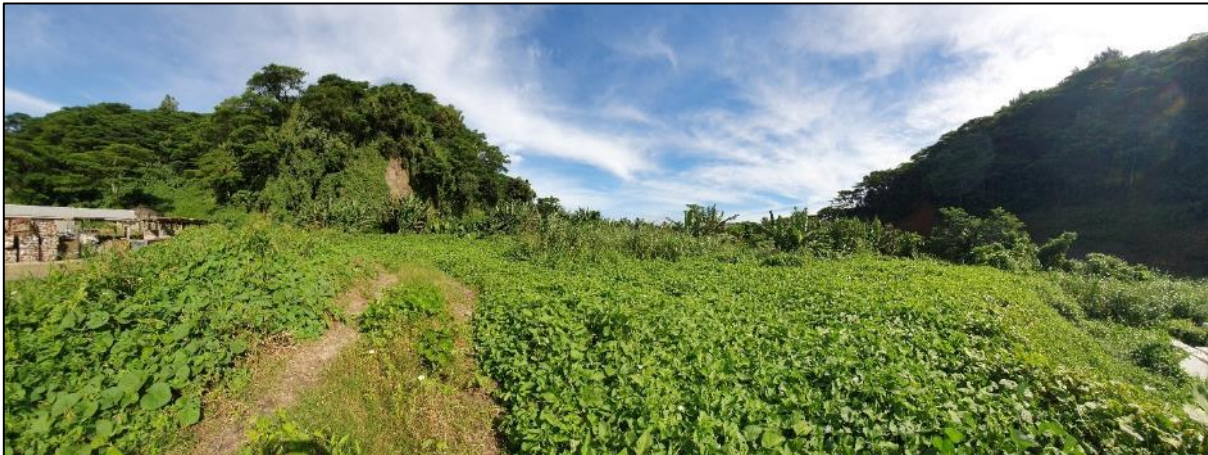
Figure 4.7: Panoramic view of the proposed disposal area

In terms of terrestrial ecological values, the vegetation and habitat around the site is modified and of low value. Various introduced trees and plants are located around the site and some native hibiscus is present in the wider site area, but outside the disposal site. The disposal area is almost completely dominated by 'mile a minute', an invasive creeper (refer to Figure 4.7).

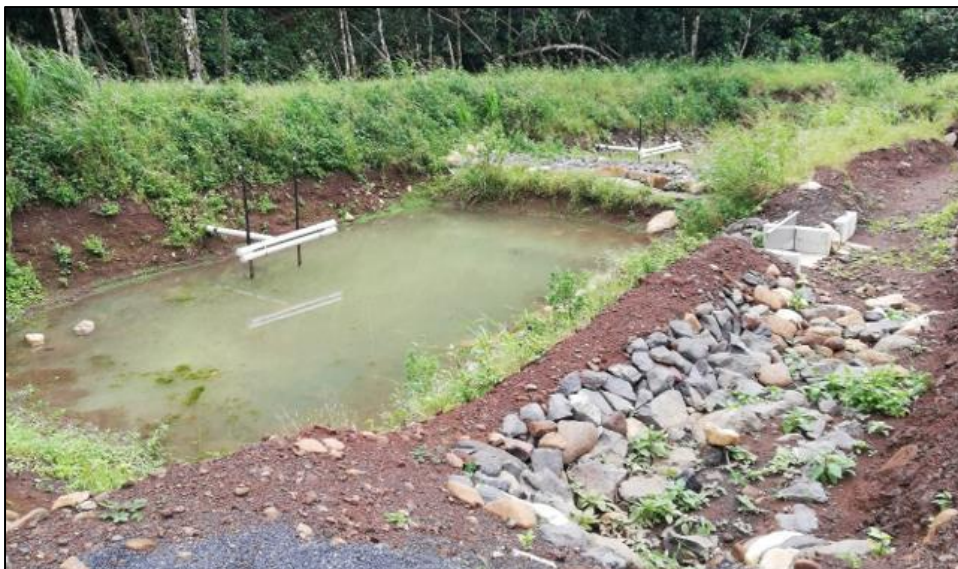
Figure 5.2: Scour pond on the Ngatote catchment.

The ponds are designed to remove sediment through a second settling process, before releasing water back to the nearest waterway. The ponds have been designed to decant through manually adjusted pipes once the water level in the ponds is high enough (refer to Figure 5.2). Additionally, some of the ponds are configured in two compartments to allow sludge to dry in one compartment while new backwash and/or settling plant sludge is directed to a second pond (refer to Figure 5.3).

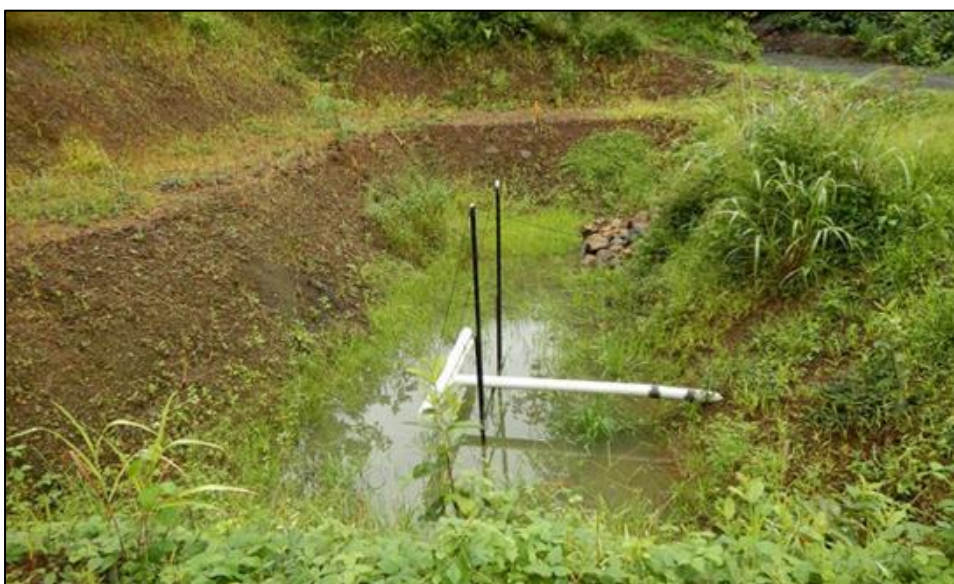
Figure 5.3: Photo of a settling pond showing the two compartments, at the Avana Water Treatment Plant.

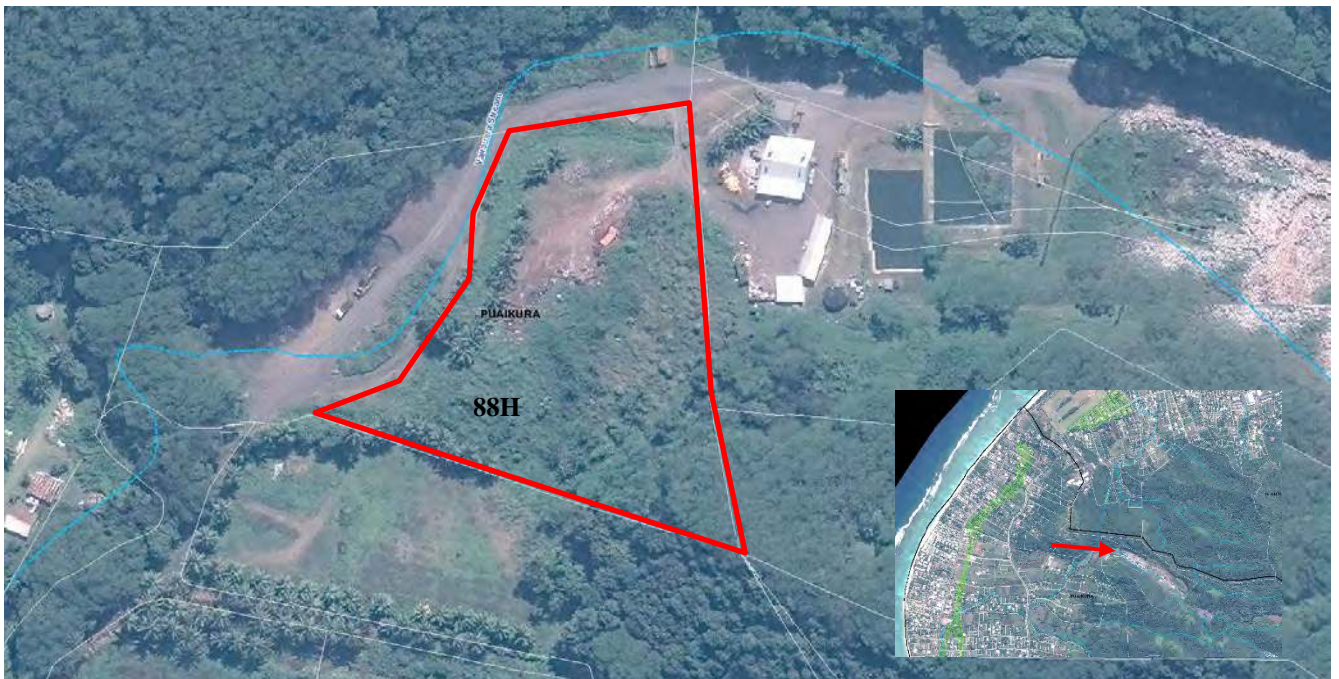
Figure 1 Site Plan

The land block is immediately downhill from the existing Arorangi Landfill. The block is slightly sloping, with an elevated vegetated platform. The site is bounded to the north by the Quarry access road and the stream, and to the south by the historic quarry rockface.

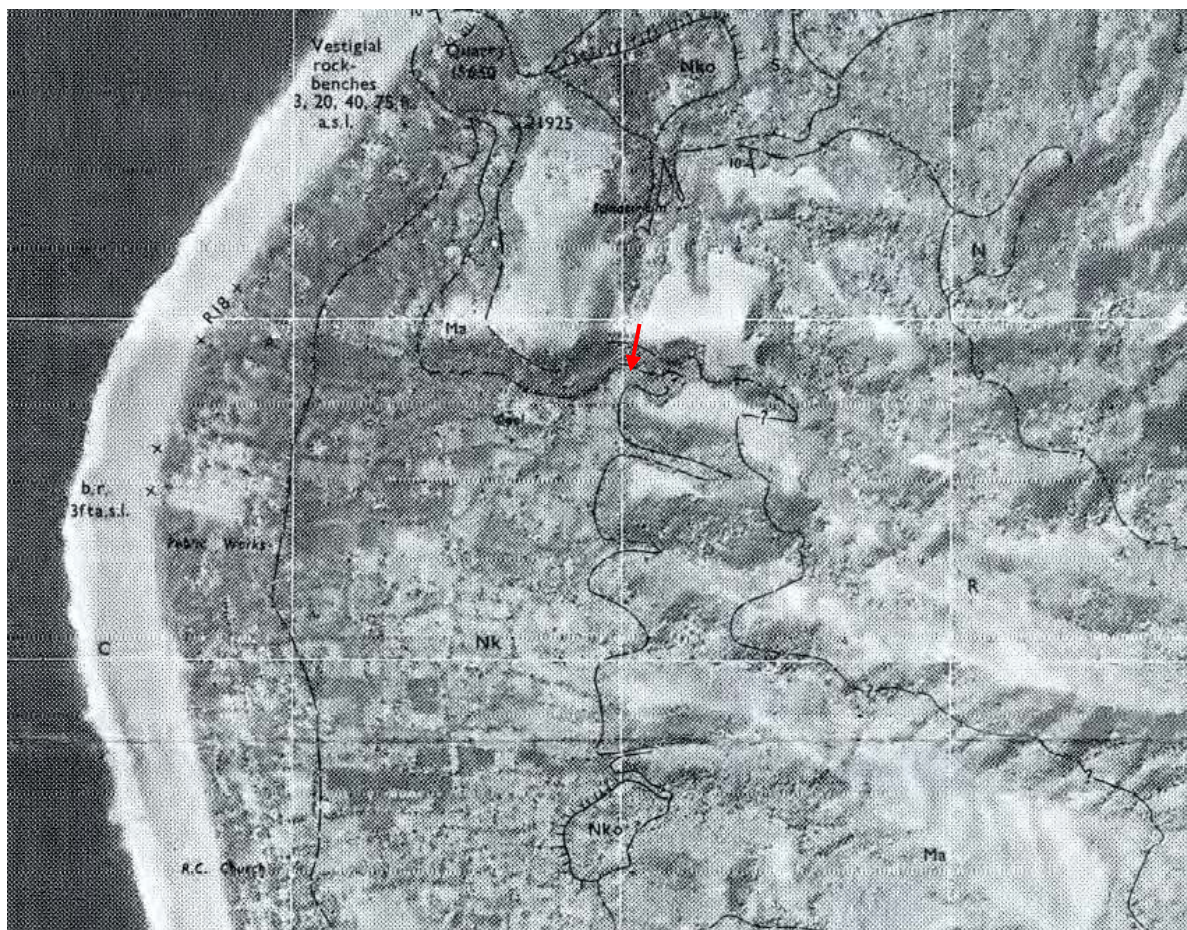
Figure 3 Geological Map of the Site (Wood & Hay, 1970. Geology of the Cook Islands, NZ Geological Survey Bulletin 82)

Raemaru Flows (**R**): light olive-green to grey dense soda phonolite, minor light-brown to yellow phonolitic ash. Prominent columnar cleavage at Black Rock. Late Pliocene to early Pleistocene.

Nikao Gravels (**Nk**): weathered volcanic gravel and sand of coastal terraces and fans; older and higher deposits (**Nko**) more deeply weathered. Late Pleistocene.

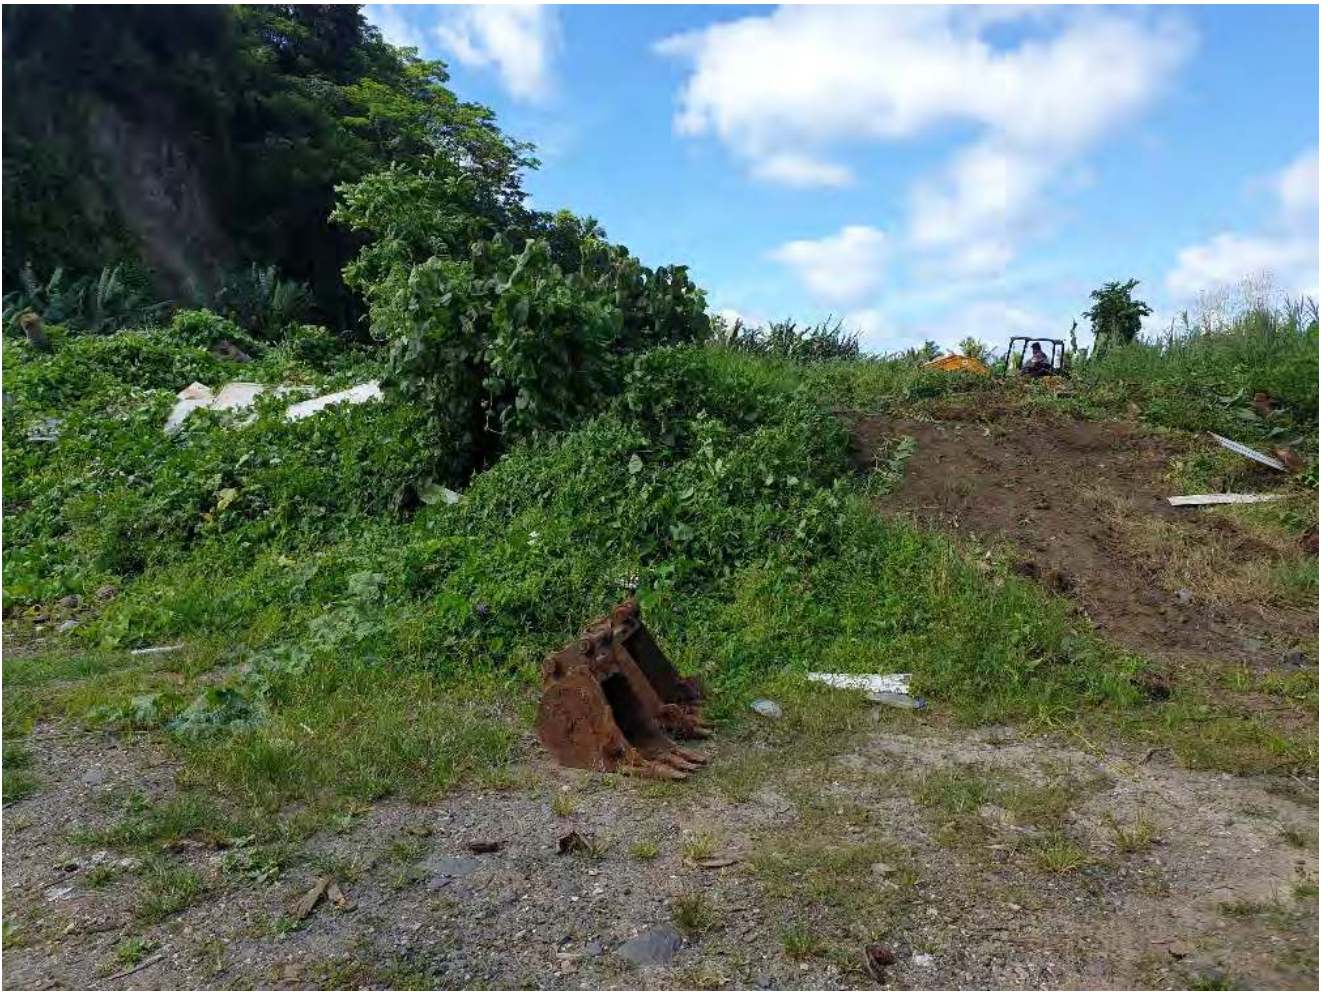
Figure 5 Site 88H fill Platform

Three test pit excavations were undertaken into the elevated platform at the site. The test pits penetrated 1.9 m depth and terminated at the extent of reach of the excavator. The elevated platform is estimated to be around 3 metres thick on average. The test pits encountered fill in all excavations, and did not encounter the natural soils below the fill platform.

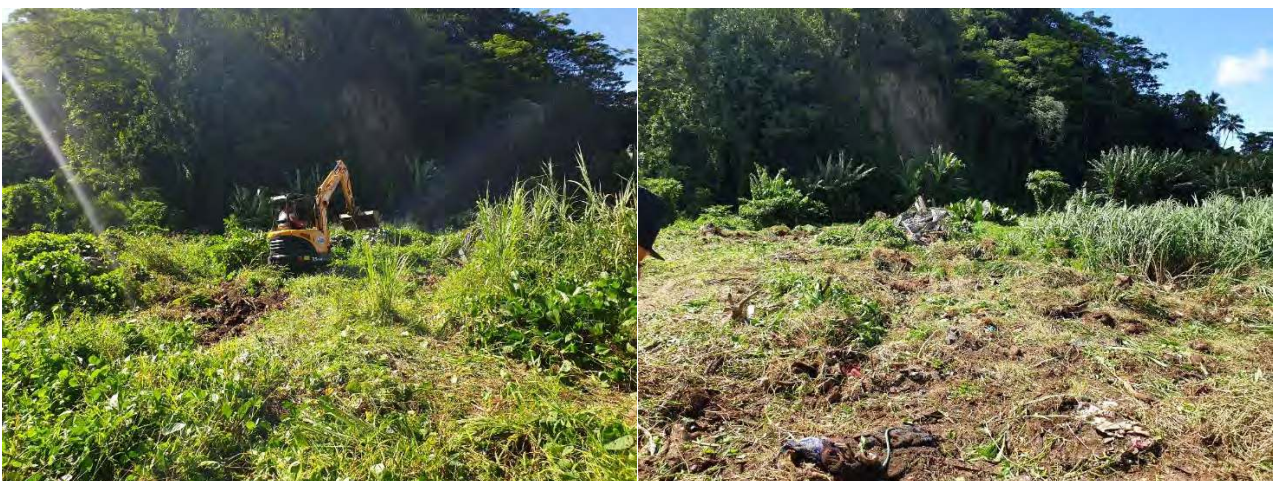
The site was heavily overgrown with vegetation and the investigation began by stripping the vegetation as best as practicable across the site.

Figure 6 Site before and after clearance

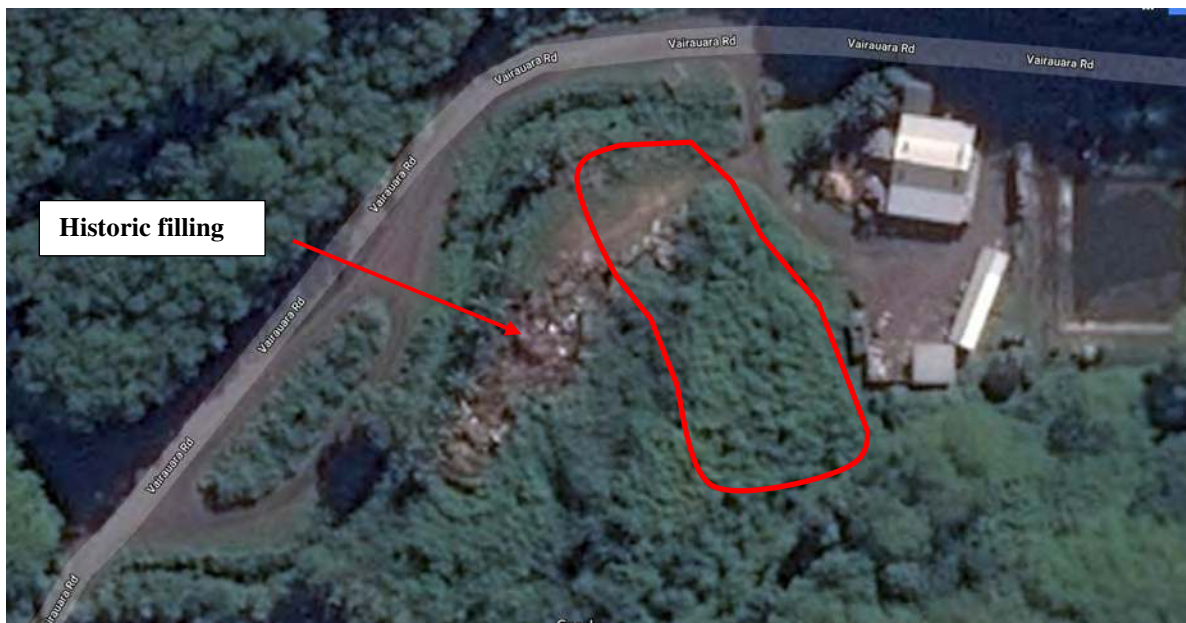
Figure 7 Approximate Area Investigated

The lot size in total, including the stream channel appears to be around 10,500 m². Approximately 1,500 m² was investigated.

Only half of the site was accessible with the 3.5 T excavator, as the other half of the site contained large logs and voids. It is presumed that the other half of the site also contains fill, as the historic aerial photos indicate filling in this area.

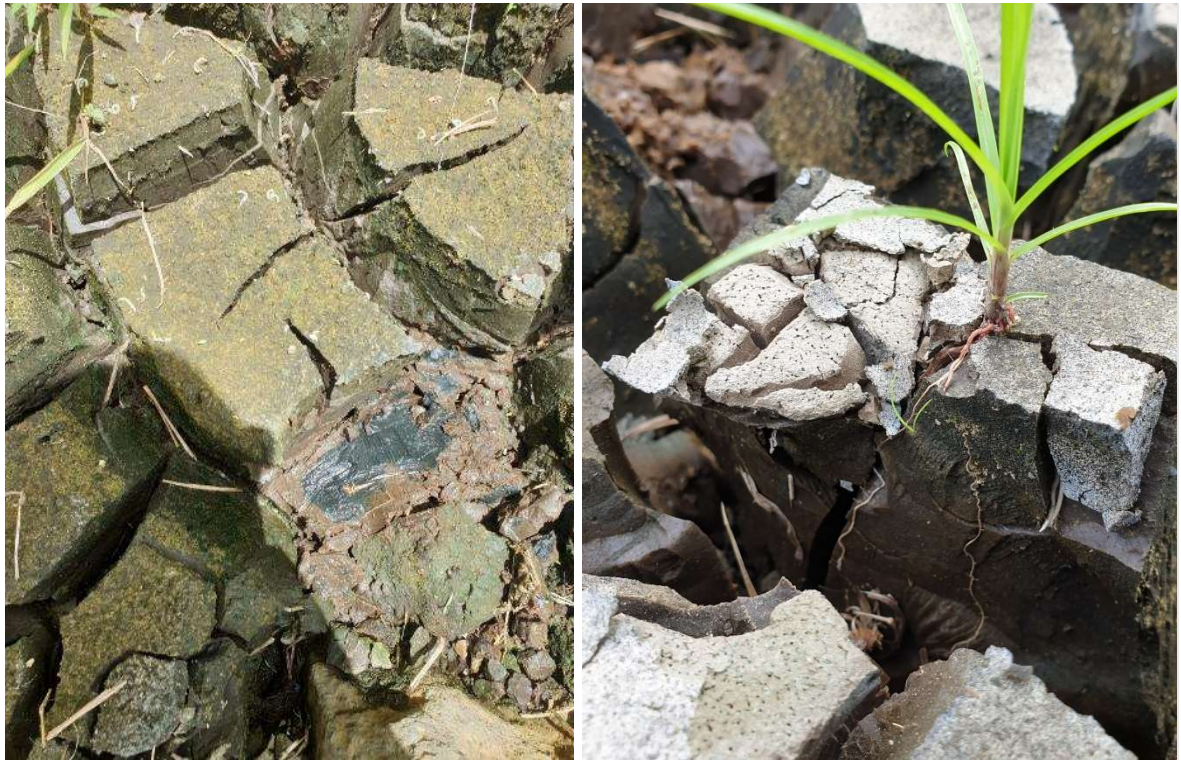
The left figure below shows the naturally dried residuals in the Tupapa standby pond (measured at 13 to 18% DS). The right figure shows dried residuals in the Ngatoe scour pond, measured at 18% DS.

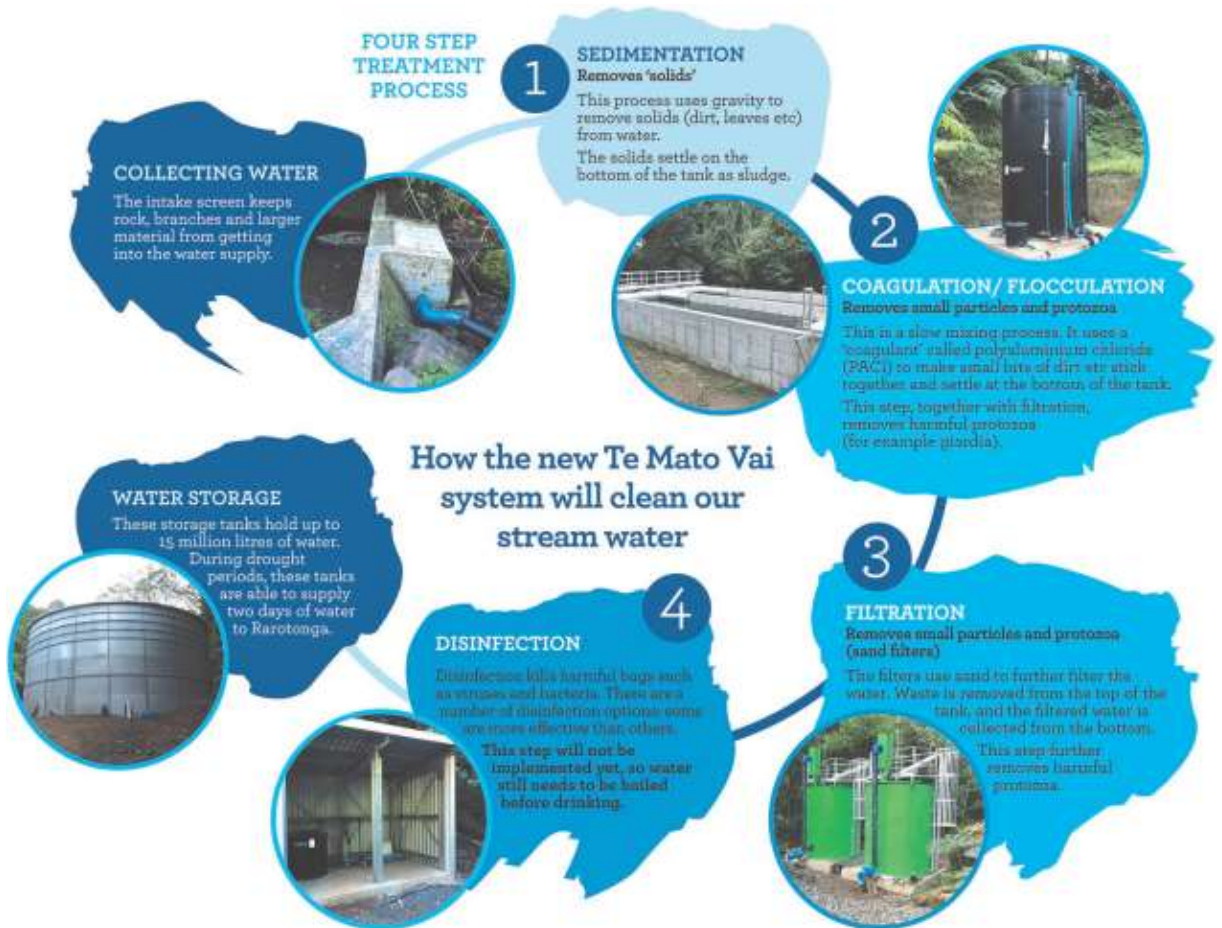
Figure 1 – Summary of the water treatment process in the new treatment plants

The Te Mato Vai project constructed ten new water treatment plants (“intakes”) at different locations in Rarotonga. The plants use the coagulant Polyaluminium Chloride (PACl), settling tanks and automated valveless gravity (AVG) filters to remove dirt, sediments, and some microorganisms from the raw water.

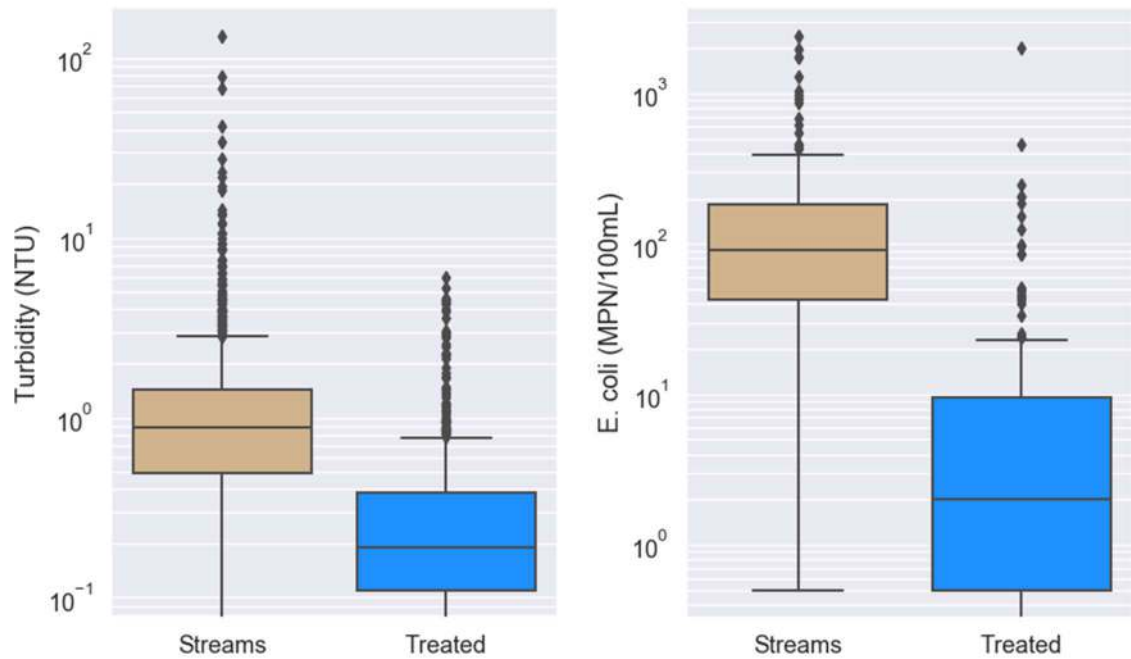
During rain events, both the reduction in turbidity and *E. coli* is significant.

Figure 6 – Improvement of water quality in terms of turbidity and *E. coli* during the trial (data until 17 Jan 2021)

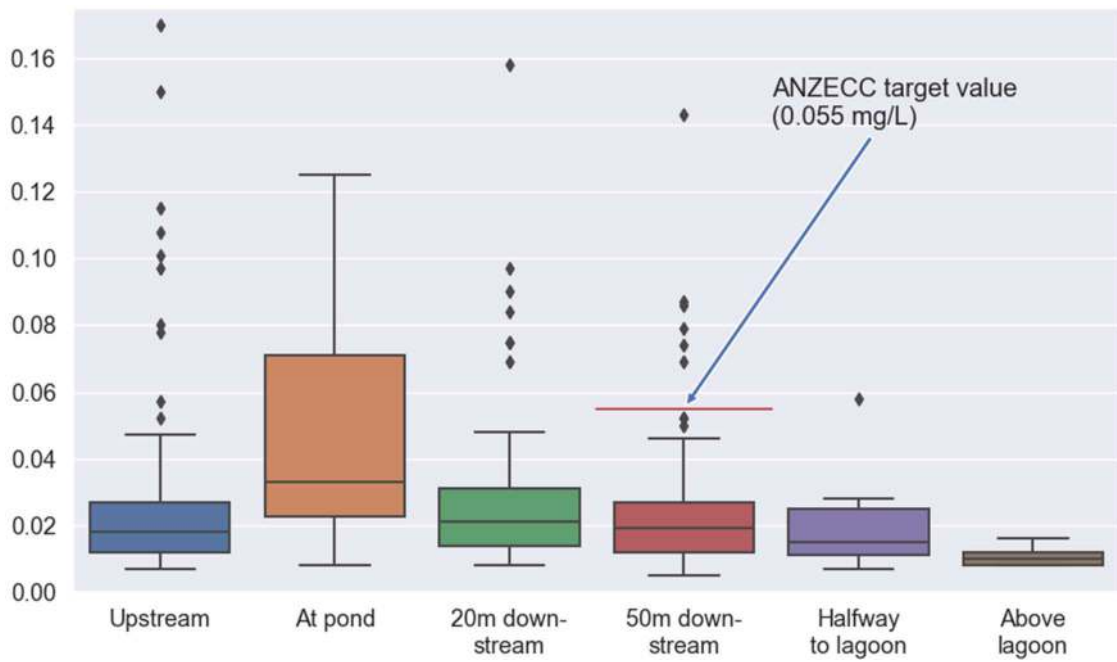
The dissolved aluminium concentrations along the streams that were measured so far during the trial are presented in Figure 9.

Figure 9 – Dissolved aluminium concentrations (in mg/L) along all streams, including peak and background samples.

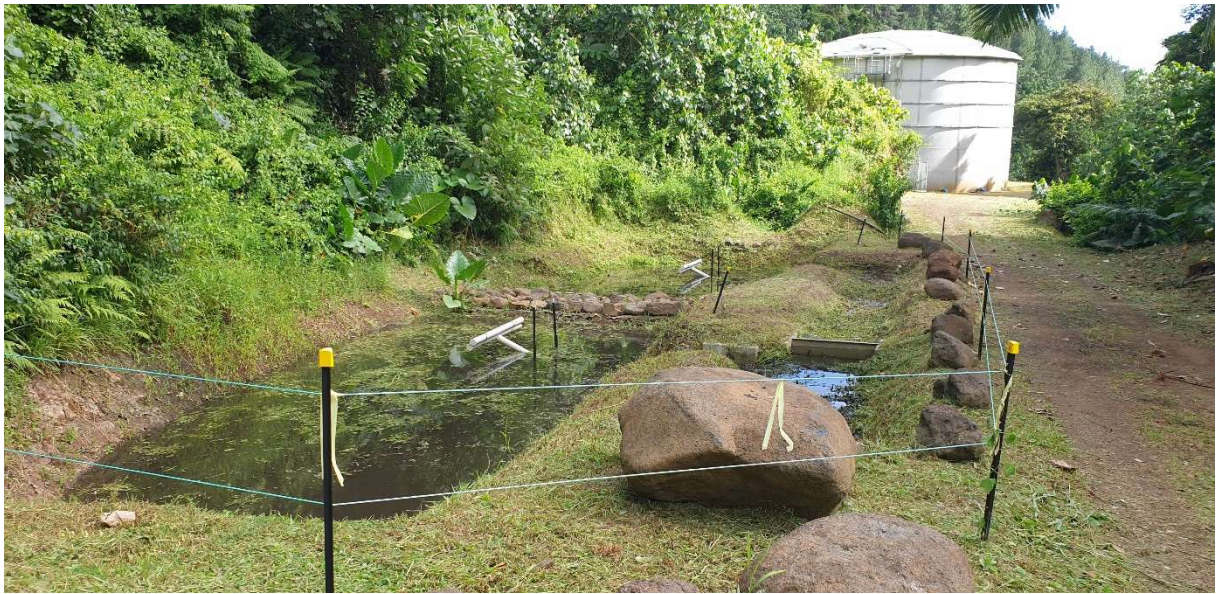
Figure 10 – Tupapa combined ponds

As already described in section 4.1 and Table 10, there are two possible pond configurations for each plant. Ngatote, Avatiu and Takuvaine have a dedicated scour pond (for settling tank sludge) and two AVG backwash ponds (duty and standby pond). All other plants have two combined AVG backwash and settling tank residuals ponds (duty and standby pond). The plants are operated so that the duty pond receives the AVG backwash and the standby pond receives the desludging residuals which allow the residuals to dry.

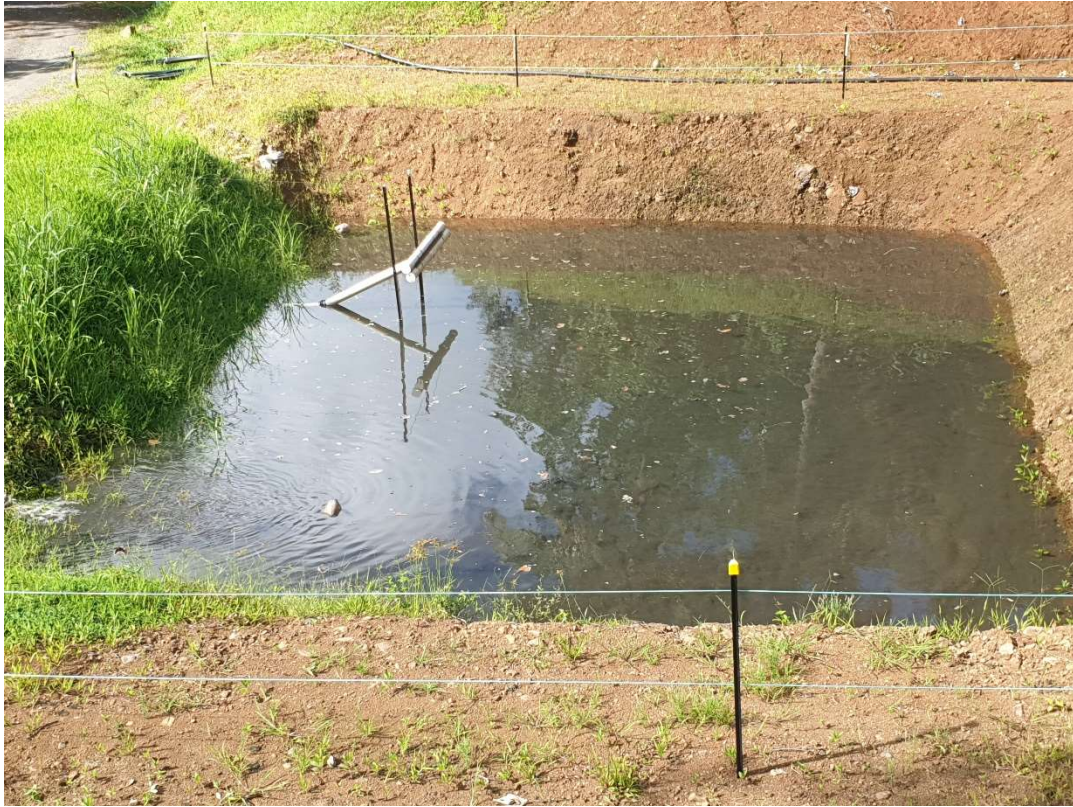
Figure 11 – Ngatoe scour pond

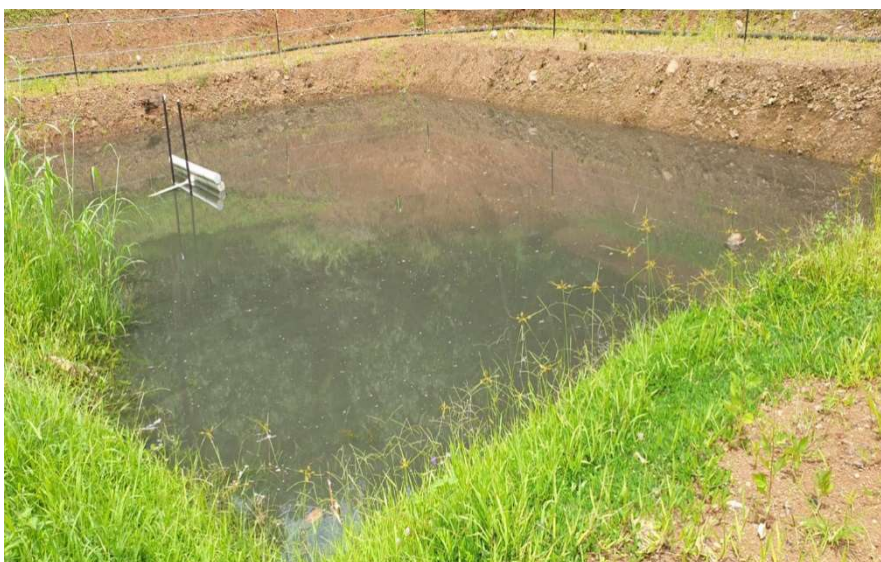
Figure 12 – Ngatoe scour pond after desludging (2 Dec 2020)

Ngatoe has a dedicated scour pond. The settling tank was de-sludged on 2 Dec 2020 (Figure 12), and residuals deposited in the scour pond. Figure 13 from 10 Dec 2020 shows that the residuals dry well. Figure 14 shows the scour pond submerged after a heavy rain event. This temporary submergence did not affect the sludge drying. Figure 15 and Figure 16 show the sludge on 12 Jan 2021. On 26 Jan 2021, the dried solids content was measured at 14% DS (Figure 18, Table 20).

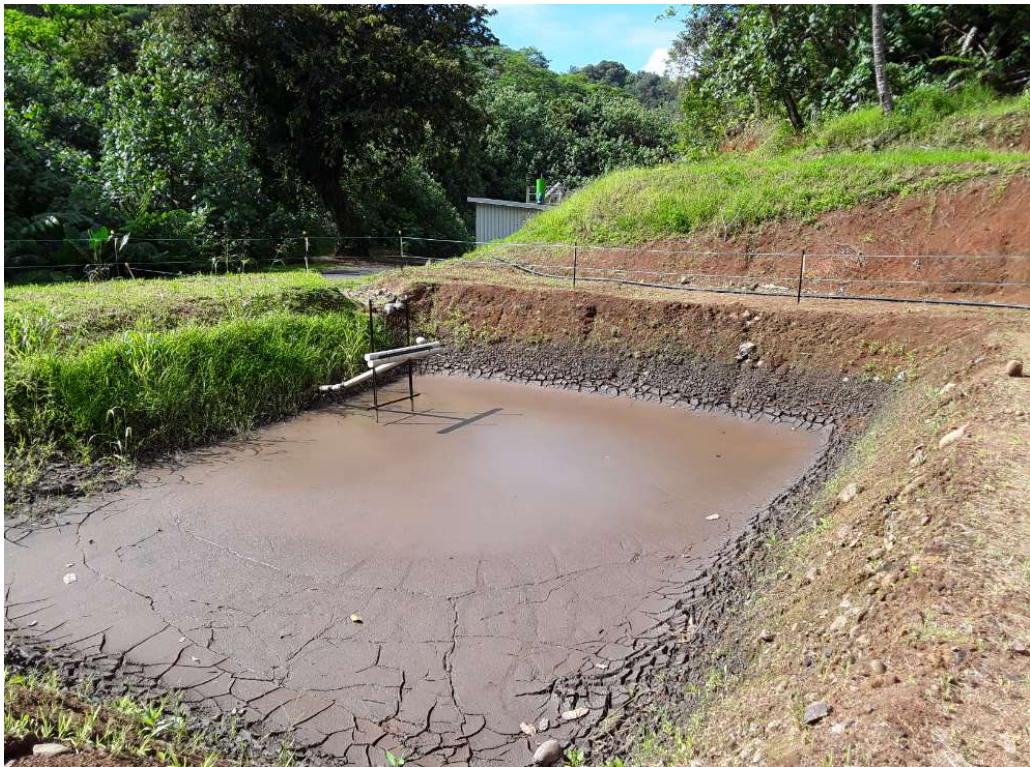
Figure 13 – Ngatoe scour pond after supernatant has dried (10 Dec 2020)

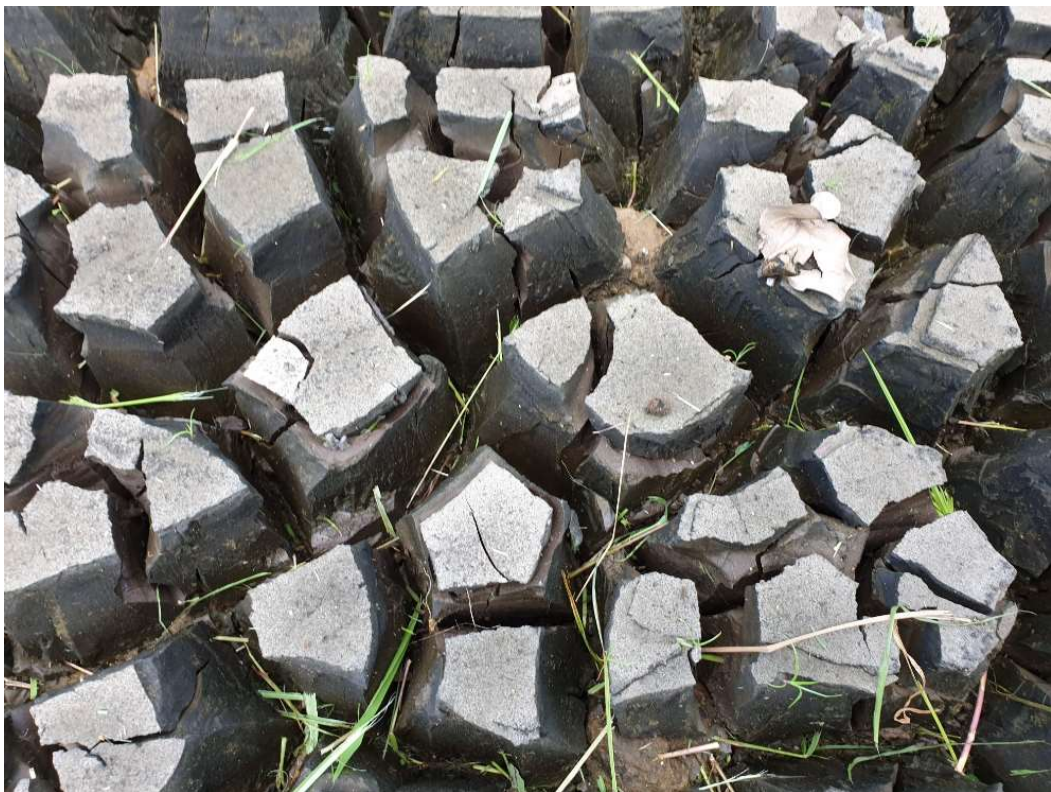
Figure 16 - Ngatoe scour pond(12 Jan 2021). Residuals are dry at the top and wetter at the bottom

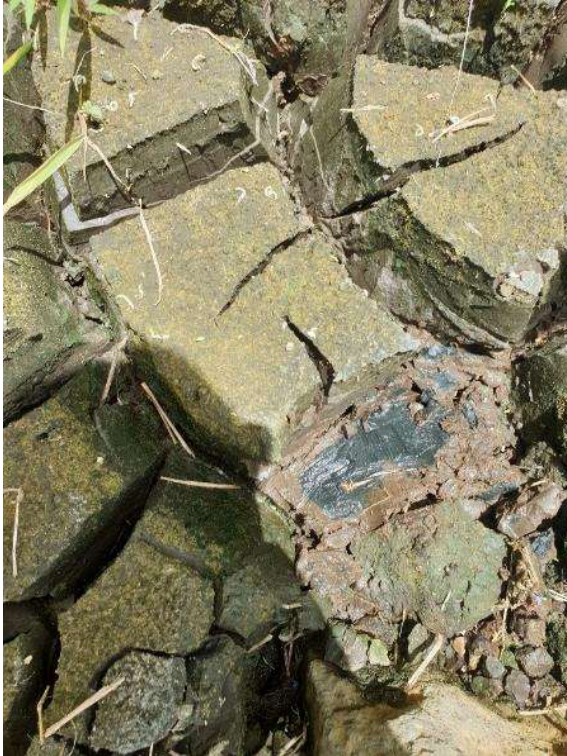
Figure 17 – Dried residuals in the Tupapa standby pond (Feb 2021, measured at 13-18% DS)

Figure 17 shows the sludge at the Tupapa standby pond approx. at the start of Feb 2021. Figure 20 shows the Tupapa standby pond on 11 Feb 2021, when a dried solids analysis for two samples showed 13 and 18% DS, respectively (Table 22).

It was also noted that different plants grow in the dried residuals (e.g. Figure 16, Figure 17, Figure 18, Figure 20, and Figure 22). An analysis of the residuals for extractable aluminium returned a concentration of less than the analytical detection limit. Based on this and other information, it is likely that the residuals could be utilised as a soil amendment in a variety of

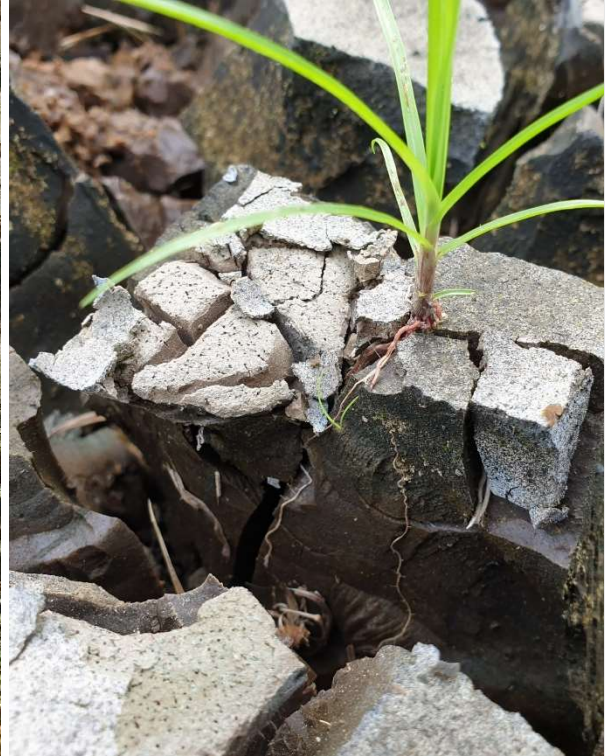
Figure 18 – Dried residuals in the Ngatote scour pond (25 Jan 2021, measured at 18% DS)

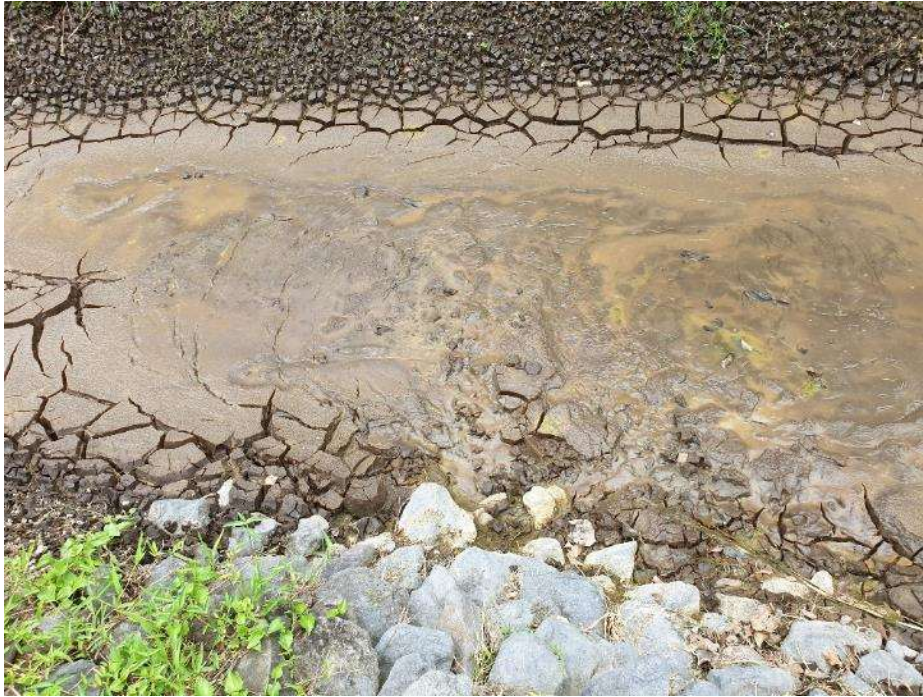
Figure 19 - Matavera pond approximately two days after discharging settling tank residuals (1 Feb 2021). The pond is in standby (drying) mode.

The Matavera settling tank was de-sludged for the second time on 28 Jan 2021. The pond with the settling tank residuals was then put on standby to allow for drying. Figure 19 shows the residuals consistency approximately two days later. A dried solids analysis of two samples showed 2.5 and 5.4% DS (Table 21).

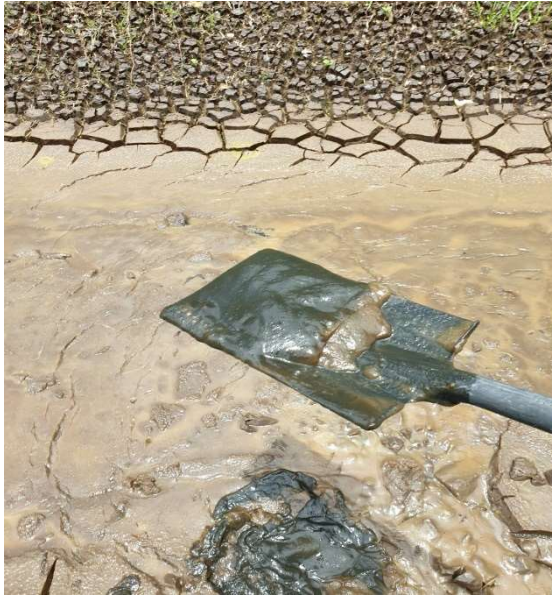
Figure 21 – Spade test at Matavera (approx. 3% DS)

The tests were carried out on 11 Feb 2021 at both Tupapa and Matavera plants, see Figure 21 and Figure 22.

The spade tests showed that there was an optimum level of drying for “spadeability”. When the water content is too high the sludge is liquid and unable to be collected on a spade. The sludge then dries to an intermediate state which is jelly like and spadable (approx. 7% DS). With further drying the sludge can become sticky and adhere to the spade, which may be more difficult to remove, sticking to excavator machinery and transport trucks (approx. 14% DS).

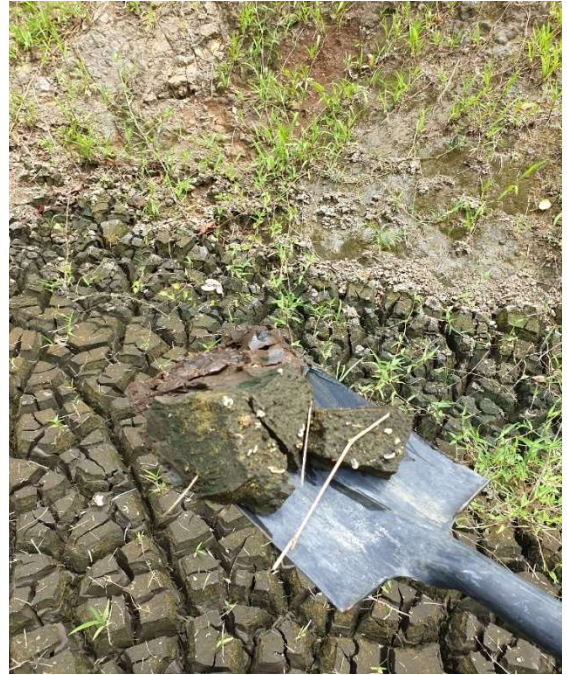
Figure 22 – Spade test at Tupapa (approx. 13-18% DS)

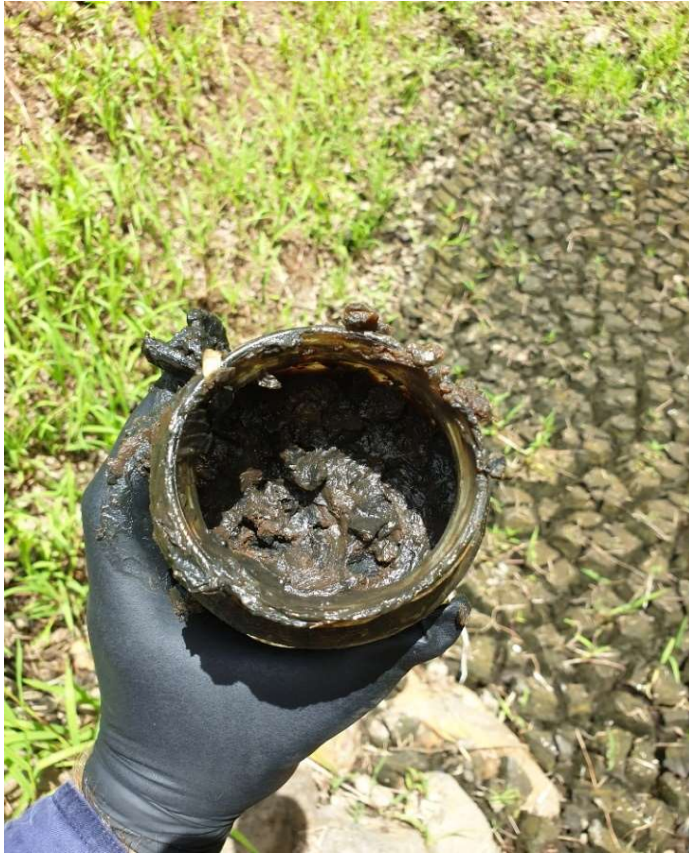
Figure 23 - Shaking test at Tupapa

The shaking test shows if water is liberated from sludge when shaking it vigorously. The jar test was conducted at the upstream standby pond (in drying mode) at Tupapa.

A sample of residuals was placed into a glass jar and shaken two ways. Shaking was undertaken first by vigorous tapping on the side of the glass, then second by vigorous shaking. In between each action the jar was opened, and the surface of the sludge was examined for free water. In both instances no free water developed on the surface of the sludge.

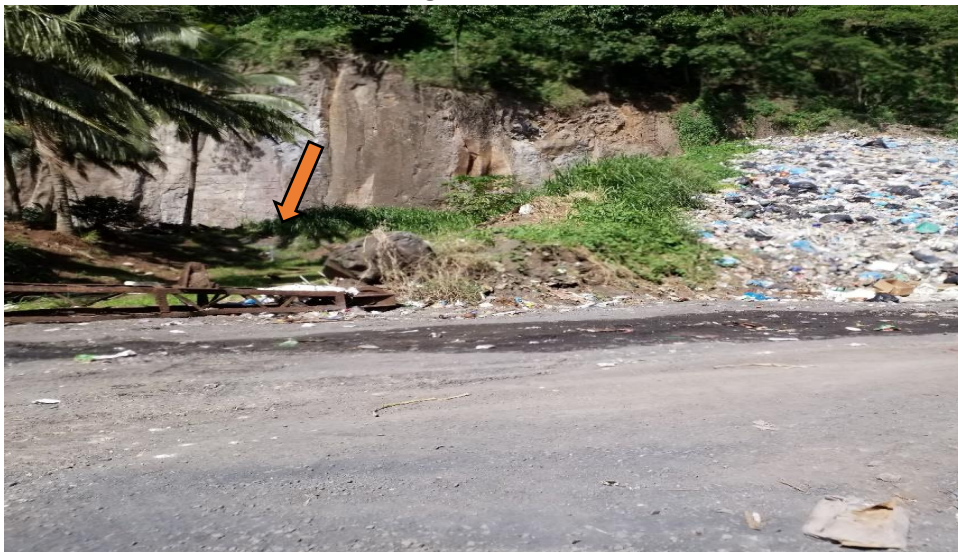
View of borehole One from existing formed road.

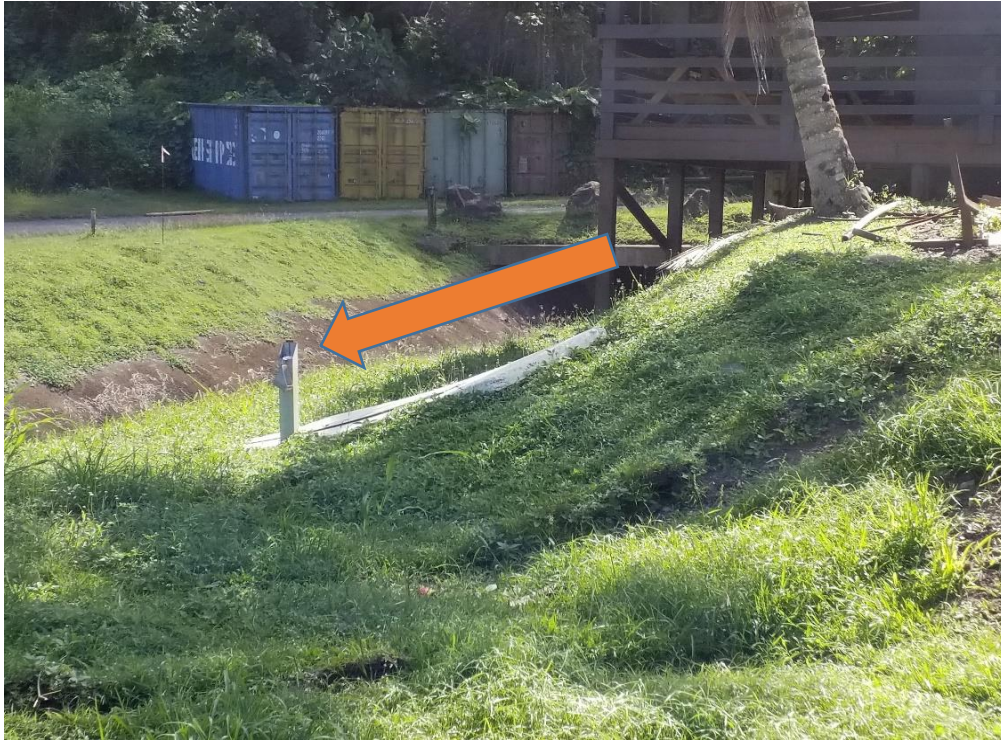
Bore hole Two located at South side of landfill. ↓

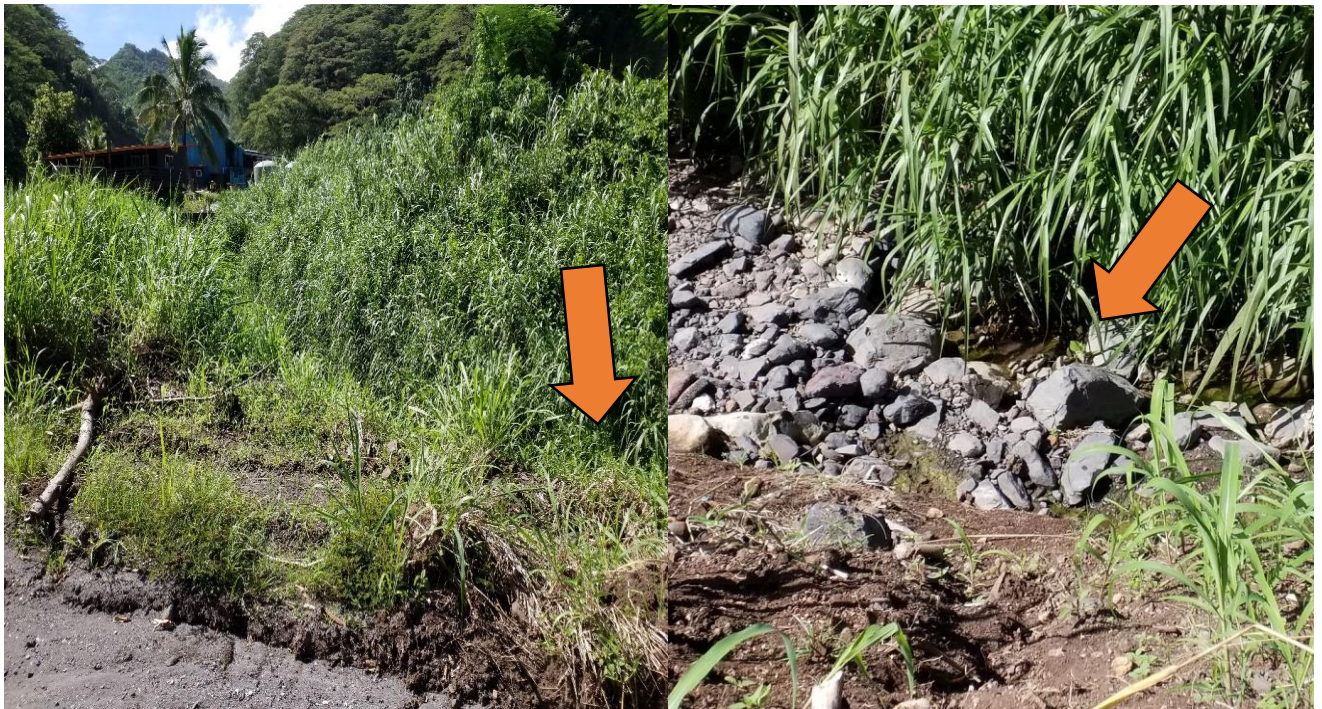
Second puddle of water were located approximately 100m downstream from bore hole Two and within 3 meters from culvert crossing.
