Sludge Disposal Site in Rarotonga
Environmental Impact Assessment

Prepared for
To Tatou Vai Limited
Prepared by
Tonkin & Taylor International Ltd
Date
July 2021
Job Number
1013086

Title: Sludge Disposal Site in Rarotonga – Environmental Impact Assessment					
Date	Version	Description	Prepared by:	Reviewed by:	Authorised by:
7.07.21	V1	Draft for TTV discussion	A Gifford	J Carvill	C Freer
12.08.21	V2	Final	A Gifford, C Purchas	C Freer	C Freer

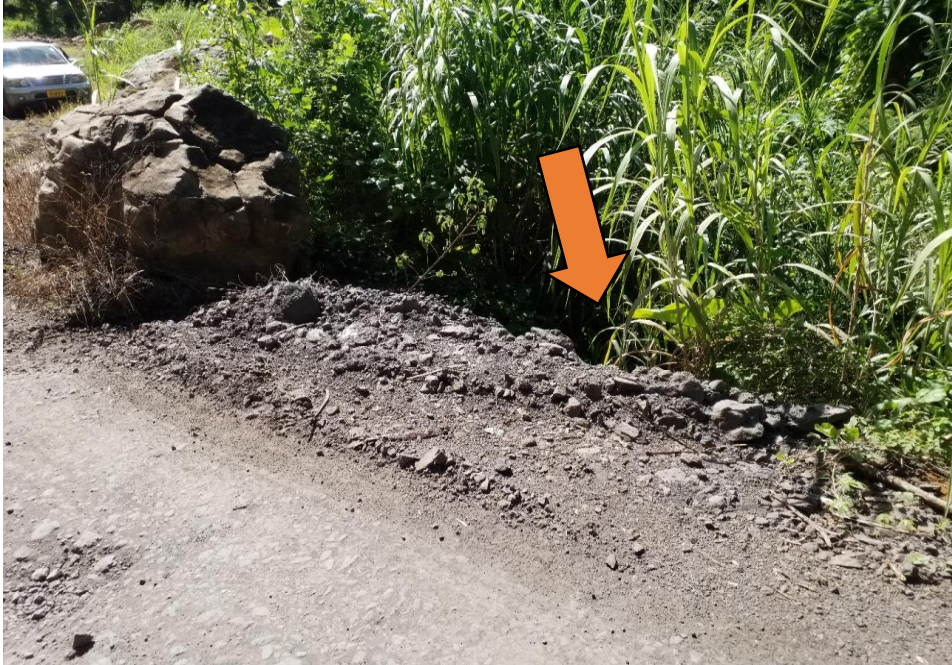
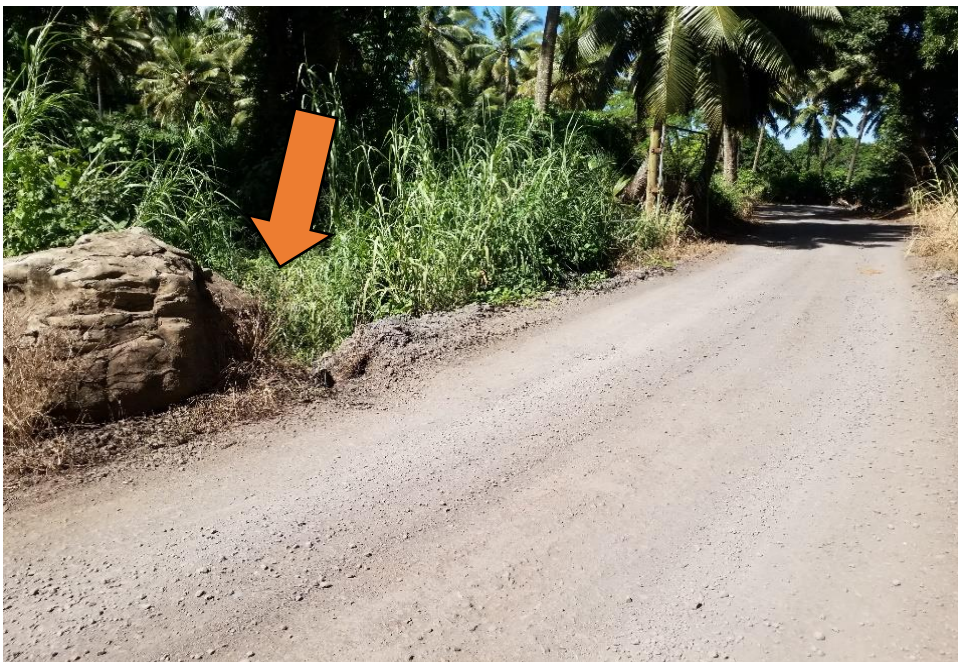
The stream had quite a thin, slim flow at approximately 50m downstream from **culvert crossing** however, disappear into underground at about after 100m. The main back road stream stretch was all dry.

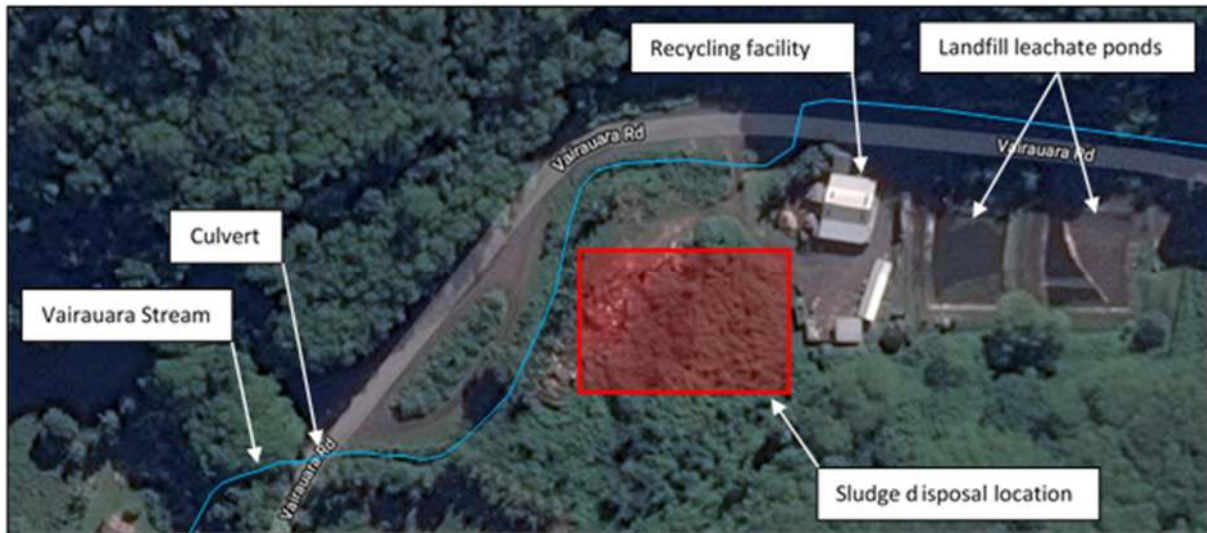
Figure 3.2: Approximate sludge disposal site with the Vairauara Stream alignment shown. The Vairauara Stream is the immediate receiving environment for discharges that may occur.

The proposed sludge disposal site (herein referred to as 'the site') is located in the north-western part of Rarotonga. The site is located within the Vairauara Stream catchment as shown in Figure 3.2.

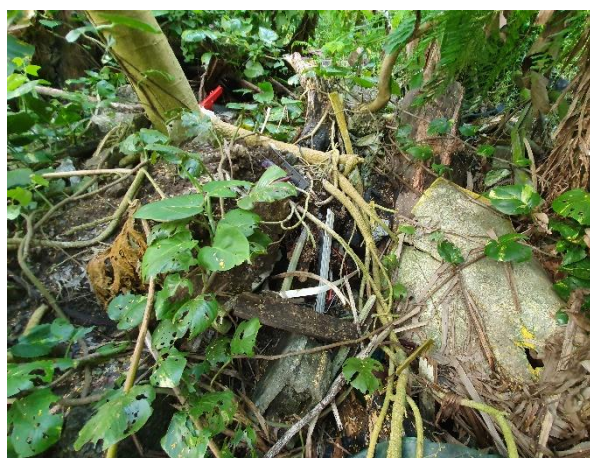
Photograph 4.1: Evidence of dumped inorganic material within vegetation, May 2021.

The site has been subject to previous land use modification including vegetation clearance, stockpiling organic and inorganic materials (Photograph 4.1, Photograph 4.2). As such, the existing ecological values on site are low and not representative of an intact ecosystem. Observations from a local landowner indicated that the site has historically been used for farming and planting local crops. The Vairauara Stream that flows adjacent to the site is reported to flow only periodically following heavy rain.

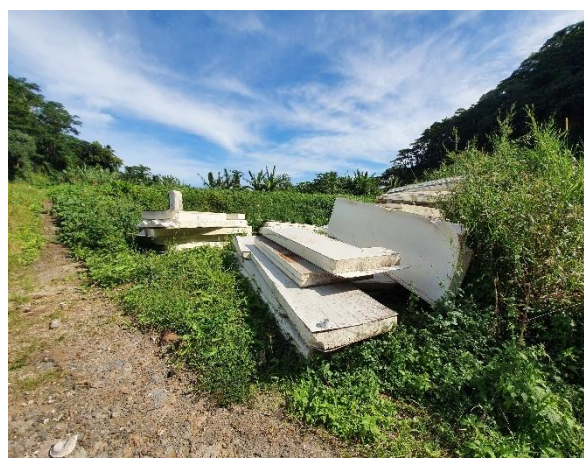
Photograph 4.2: Materials within the proposed disposal area, May 2021.

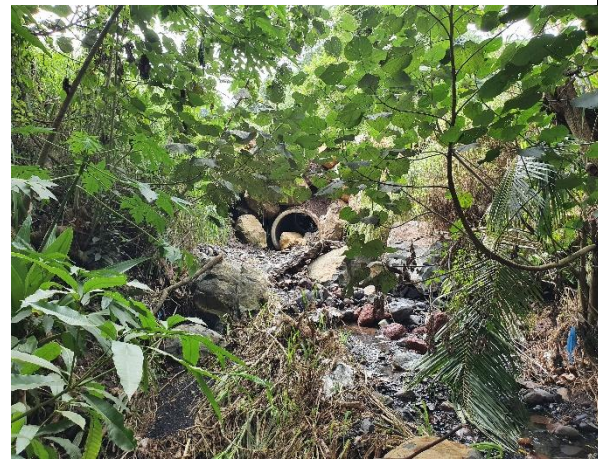
Photograph 4.4: Culvert along Vairauara Stream, some shallow pools of water present in foreground, May 2021.

During the May 2021 site visit the stream had very little water present, with only a few small, isolated shallow pools (Photograph 4.3, Photograph 4.4). This was observed to be the case in March 2021 as well. The site visit was undertaken near the end of the wet season, when stream flows would be expected to be present. Anecdotal evidence from the nearby landowner indicates that the stream rarely flows, only following heavy rainfall events. This is typical for streams with short catchments on this side of the island (refer to a similar Environmental Impact Assessment, prepared by Tauei Enuarurutini Teauariki Lands Incorporated and Island Quarrying Limited, 2017).

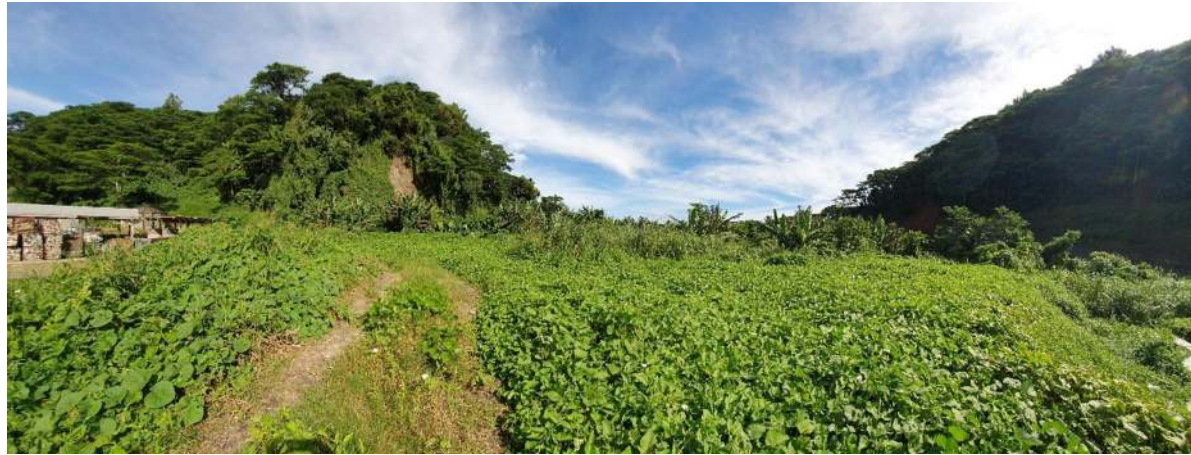
Photograph 4.5: Panoramic photograph of proposed disposal area, May 2021.

Within the disposal area, the terrestrial vegetation values are limited due to historic land use and the stockpiling/dumping of material. The disposal area is almost completely dominated by mile a minute, an invasive creeper.
