# Natural Resource Condition Assessment

## *American Memorial Park*

Natural Resource Report NPS/AMME/NRR—2019/1976

August 2019

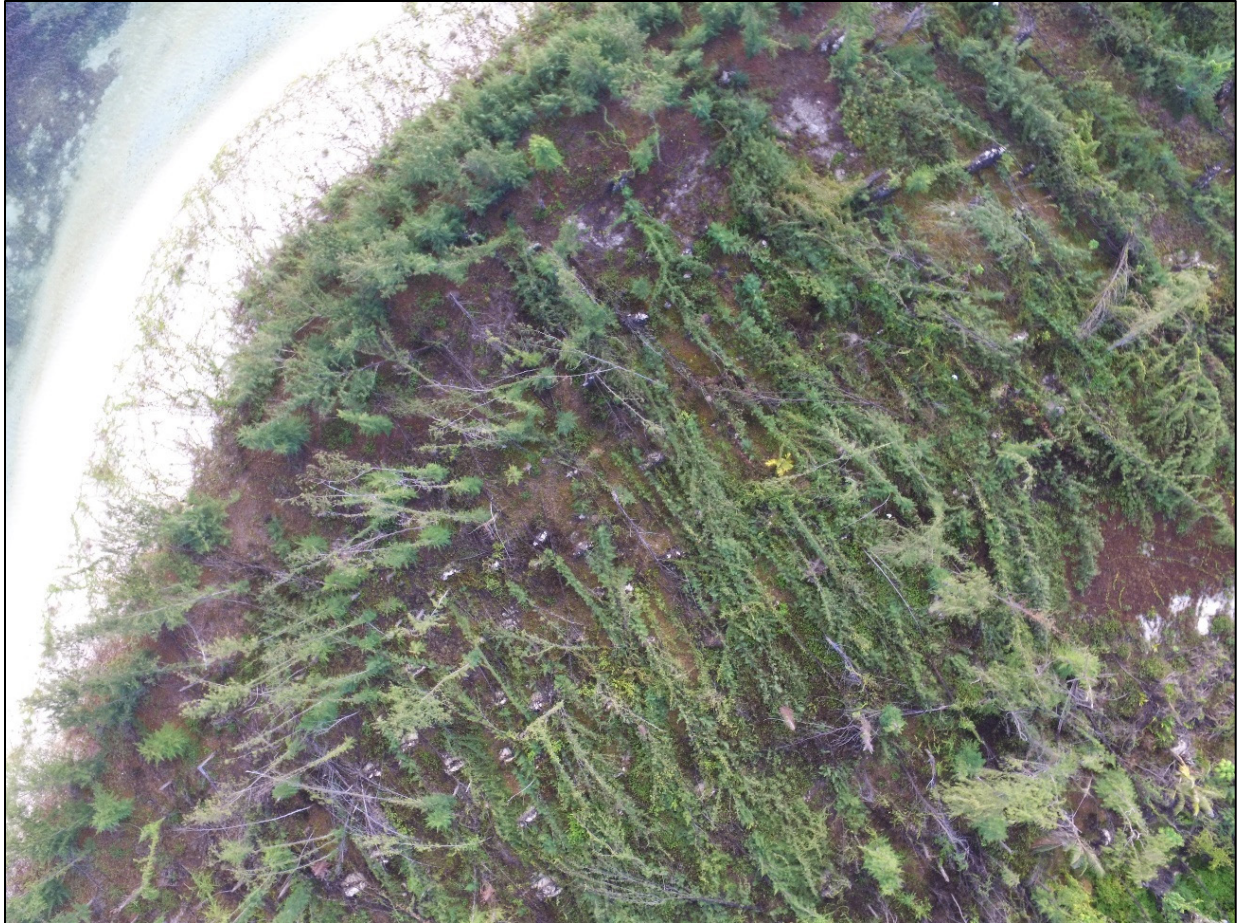
**Figure 6.** Aerial photo of felled secondary forest in American Memorial Park after Typhoon Soudelor (Photo by M. Kottermair 2016).

The largest patch of secondary forest northeast of the bike path was heavily damaged by Typhoon Soudelor in 2015, which killed many ironwoods and felled nearly 90% of trees within the park (NPS 2017, see Figure 6). Figure 29 shows this patch prior to typhoon damage via oblique imagery taken by CNMI Coastal Resources Management Office in 2009 during a period of rapid beach growth along the sand spit at Smiling Cove Marina and subsequent vegetation succession.

The typhoon caused forty injuries, the loss or severe damage of almost four hundred homes, spillage of five-hundred-gallons of diesel fuel into the port, and a total of \$20 million in damages. American Memorial Park sustained immense damage to the Park’s ironwood forest (see Figure 6). The playground was destroyed, many large trees were felled, and large portions of the park were closed to the public for months. The root balls of the felled ironwood trees prompted archaeological studies of the area (Maigret 2015). Park-specific ecological effects have yet to be studied and measured; however, the nearshore environment and shoreline configuration has shifted significantly since the storm.

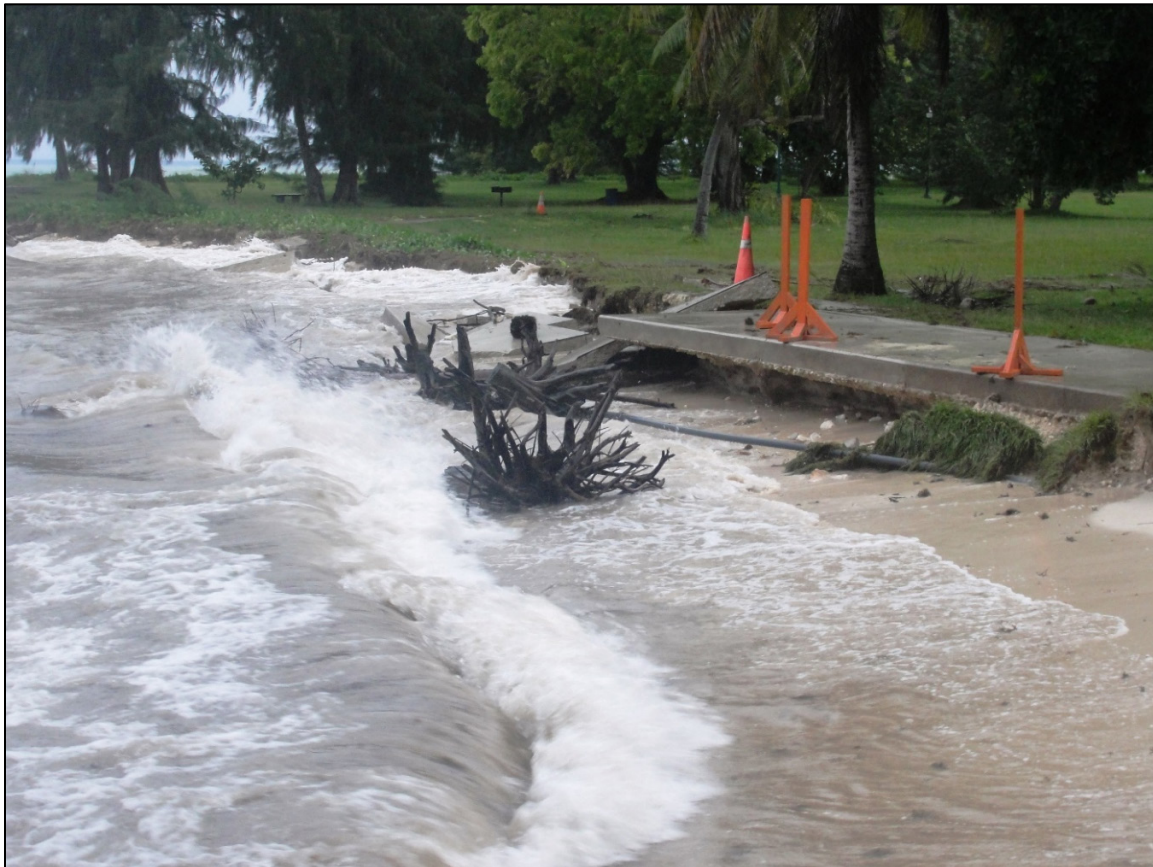
**Figure 26.** A section of collapsed sidewalk and adjacent eroded shoreline during a high tide and large west swell at American Memorial Park (Photo by R. Greene 2013).

With respect to the physical landscape, the shoreline of American Memorial Park is a focal point in the CNMI for the study and management of coastal erosion and the compounding effects of sea level variability and storm activity. The beaches and nearshore waters along the Park's western and northern boundaries are dynamic, as evidenced by comparative analysis of historic shoreline positions as well as documentation of tangible impacts (Figure 26).

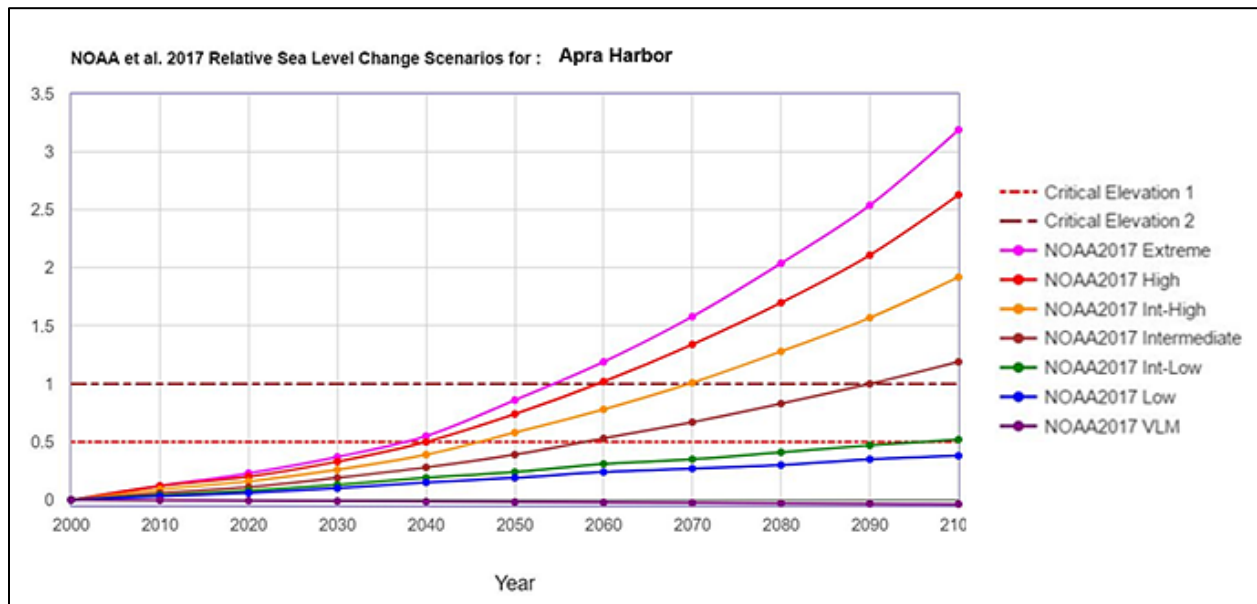
**Figure 27.** Sea level curves (meters) for the Apra Harbor Tide Gauge on Guam (NOAA 2017).

Based on NOAA’s most recent report on global and regional sea level trends and scenarios (NOAA 2017) and calculations of local sea level scenarios using the U.S. Army Corps of Engineers (USACE) Sea Level Curve Calculator (USACE 2017), shifts in global, regional, and sub-regional climate conditions are expected to cause sea level change rates at American Memorial Park in exceedance of the global rates. Using these updated resources, Figure 27 and Table 5 highlight a range of potential sea levels at American Memorial Park. These sea levels and associated rates of change are partially based on sea level records from the tide gauge in Apra Harbor, Guam. This station holds the most consistent, long-term records for the Marianas Archipelago and serves as the basis for NOAA’s Center for Operational Oceanographic Products and Services’ sea level trend calculations for the Marianas. It is therefore used as a proxy for sea level trends at AMP in this report. Revised intermediate to extreme projections based on the Apra Harbor gauge range from 0.67 m (2.2 ft.) to 1.58 m (5.2 ft.) by 2070, roughly 50 years from the date of publication of this NRCA (NOAA 2017; USACE 2017).

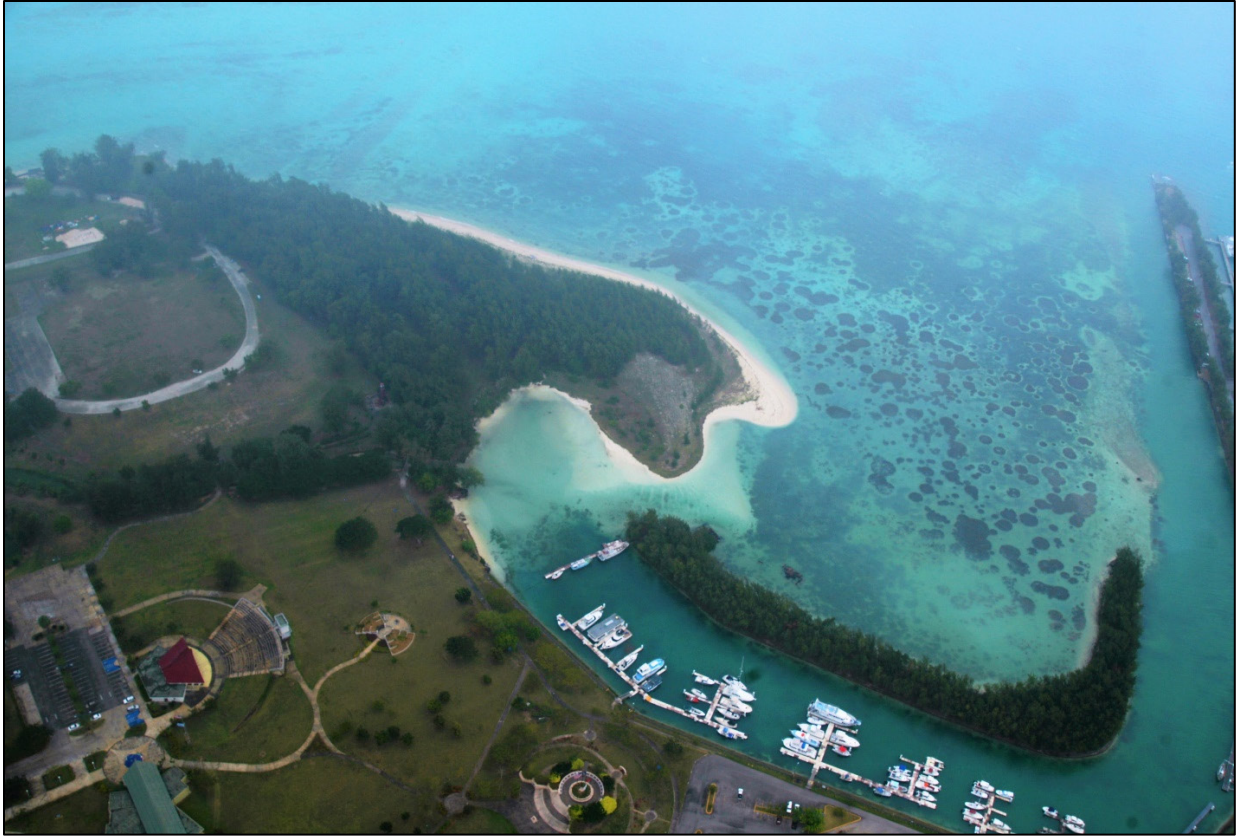
**Figure 29.** Oblique image of American Memorial Park's ironwood forest in 2009 (Photo courtesy of CNMI CRMO).

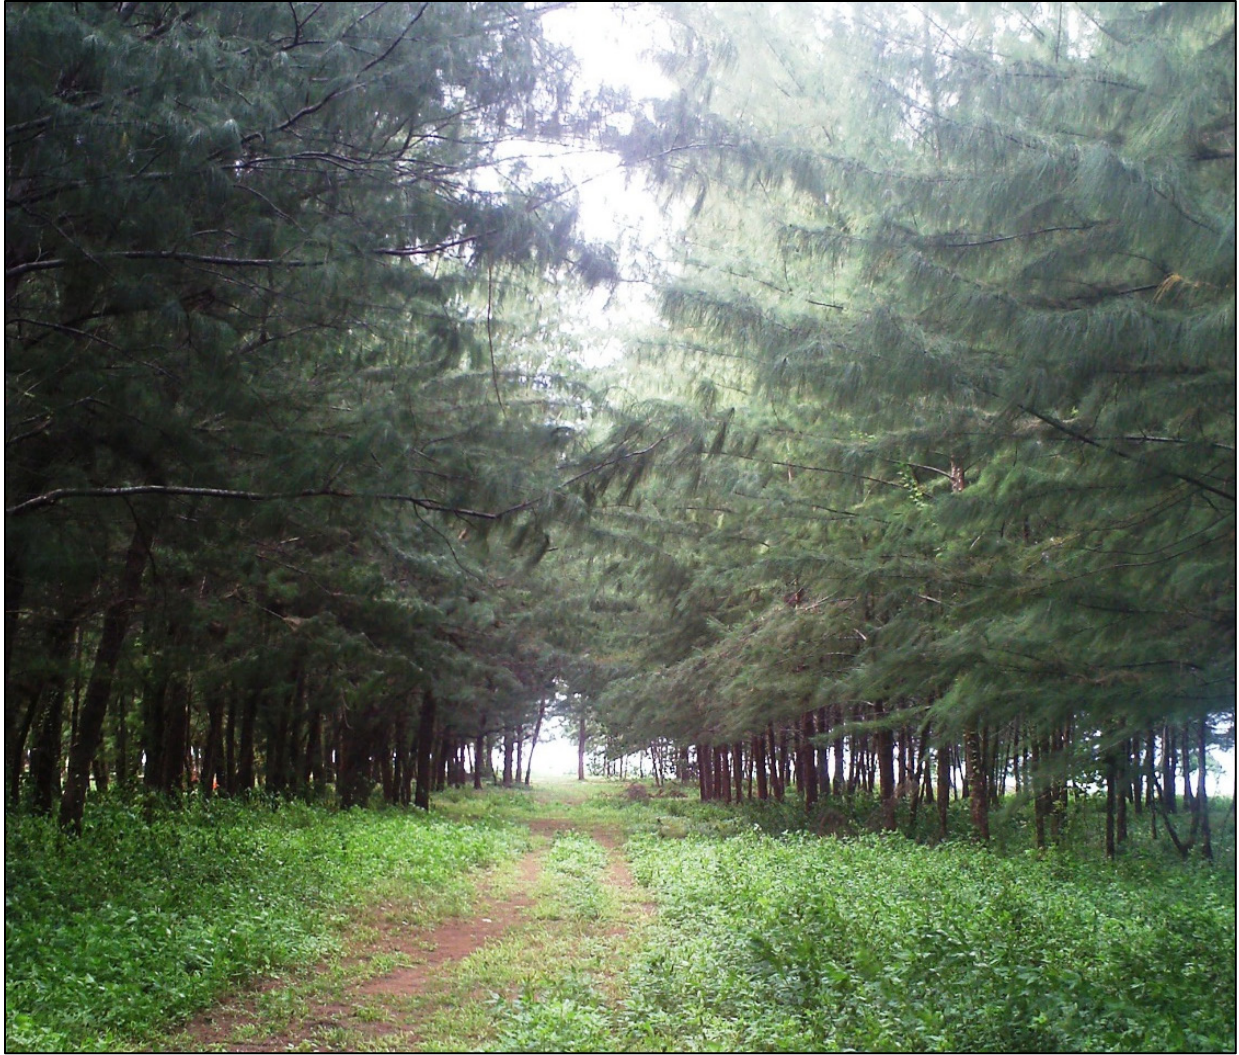
The ironwoods have been the primary successors following establishment of shoreline strand vegetation in this part of the Park, as accretion caused the shoreline to shift seaward to 6.5 m (21.33 ft) per year between 2003 and 2011 (Greene and Skeele 2014). Figure 30 illustrates this succession, showing parallel stands of ironwoods along the accreting sand spit in 2013, with older, taller pines on the left, and more recently established, shorter pines on the right (closer to the growing shoreline).

**Figure 30.** Parallel ironwood stands illustrating forest succession in American Memorial Park (Photo by R. Greene 2013).

Additionally, the most substantial patch of ironwood forest did not exist in 1989 because the underlying soil is a product of rapid beach growth that has persisted since the early 2000s. The area was formerly submerged. Adjacent stands of trees in a range of growth stages can be seen in this large patch of secondary forest (Yuknavage and Palmer 2010; Figure 30), showing a clear successional pattern of the forest following accretion and growth of new shoreline.

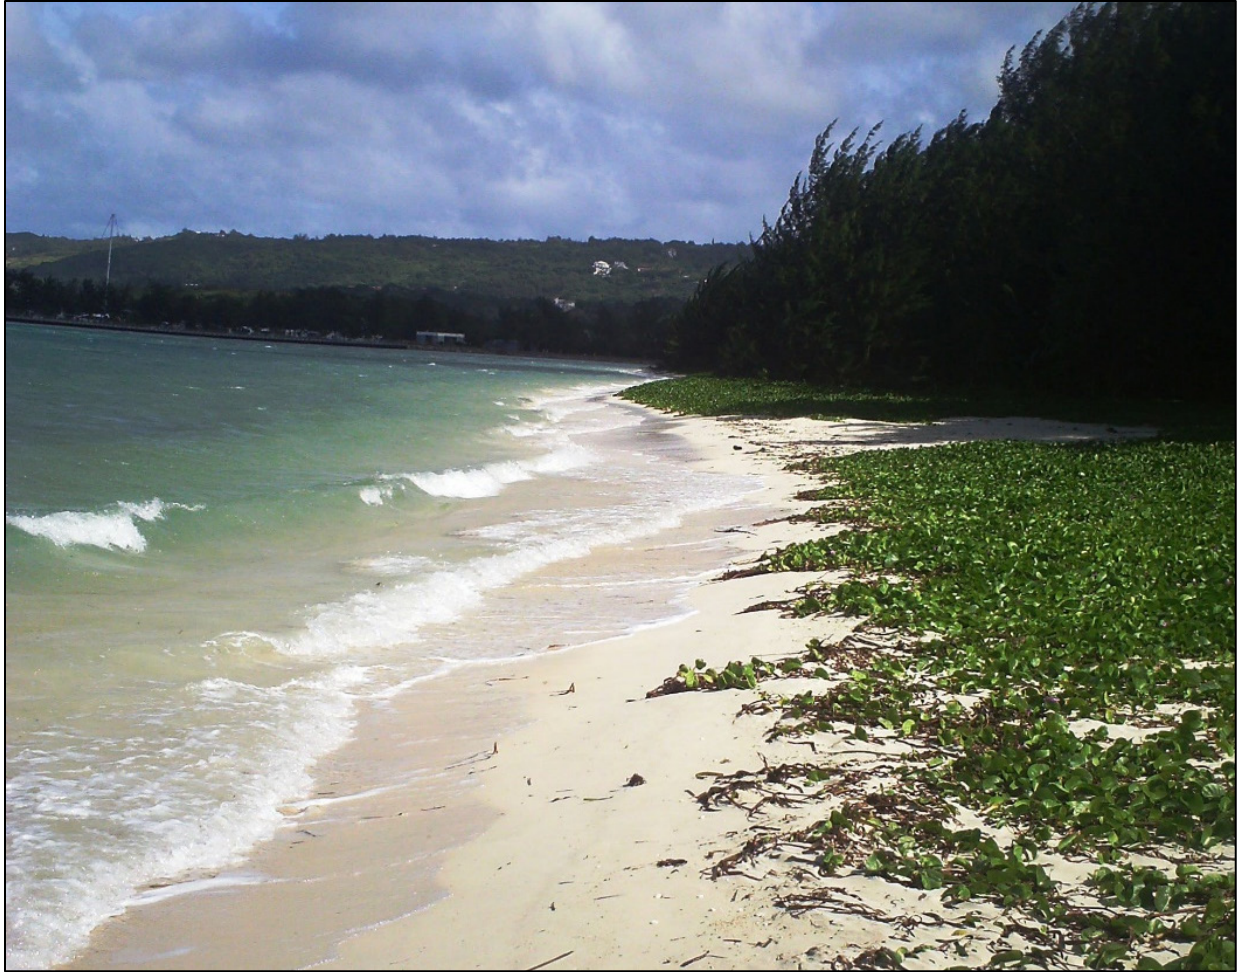
**Figure 31.** Unconsolidated shoreline and strand vegetation at the north end of Micro Beach in American Memorial Park (Photo by R. Greene 2012).

Although the park boundary terminates at mean high water, the near-shore areas and benthic habitat of Saipan Lagoon are also included in the NRCA conditions ratings for the services they provide to park resources, especially erosion mitigation and recreational attractions (Figure 31). The NRCA near-shore resource is defined as the water column and benthos within 100 m (328.08 ft) of the shoreline, which consists largely of bare sand, seagrass, macro algae, and coral rubble (Kendall et al. 2017). Additionally, pelagic avian species and migratory shorebirds such as the Pacific golden plover (*Pluvialis fulva*) use some areas of the shoreline for foraging, especially the tidal flats near the marina.

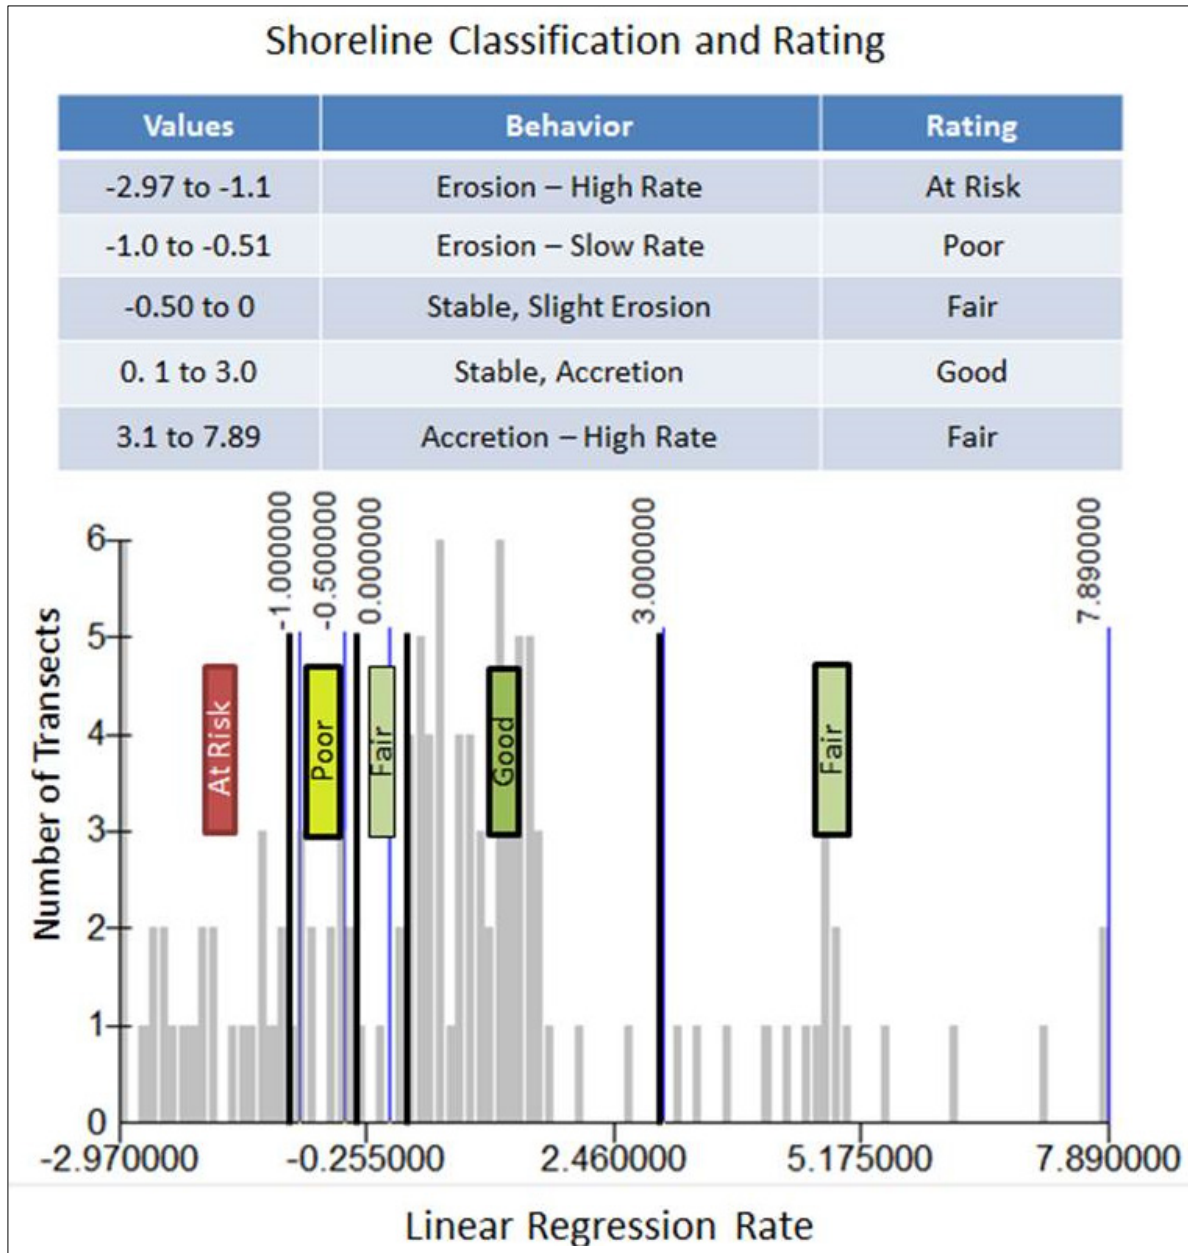
**Figure 34.** Shoreline change classification (m/yr.) for beach transects at American Memorial Park (Greene and Skeele 2014).

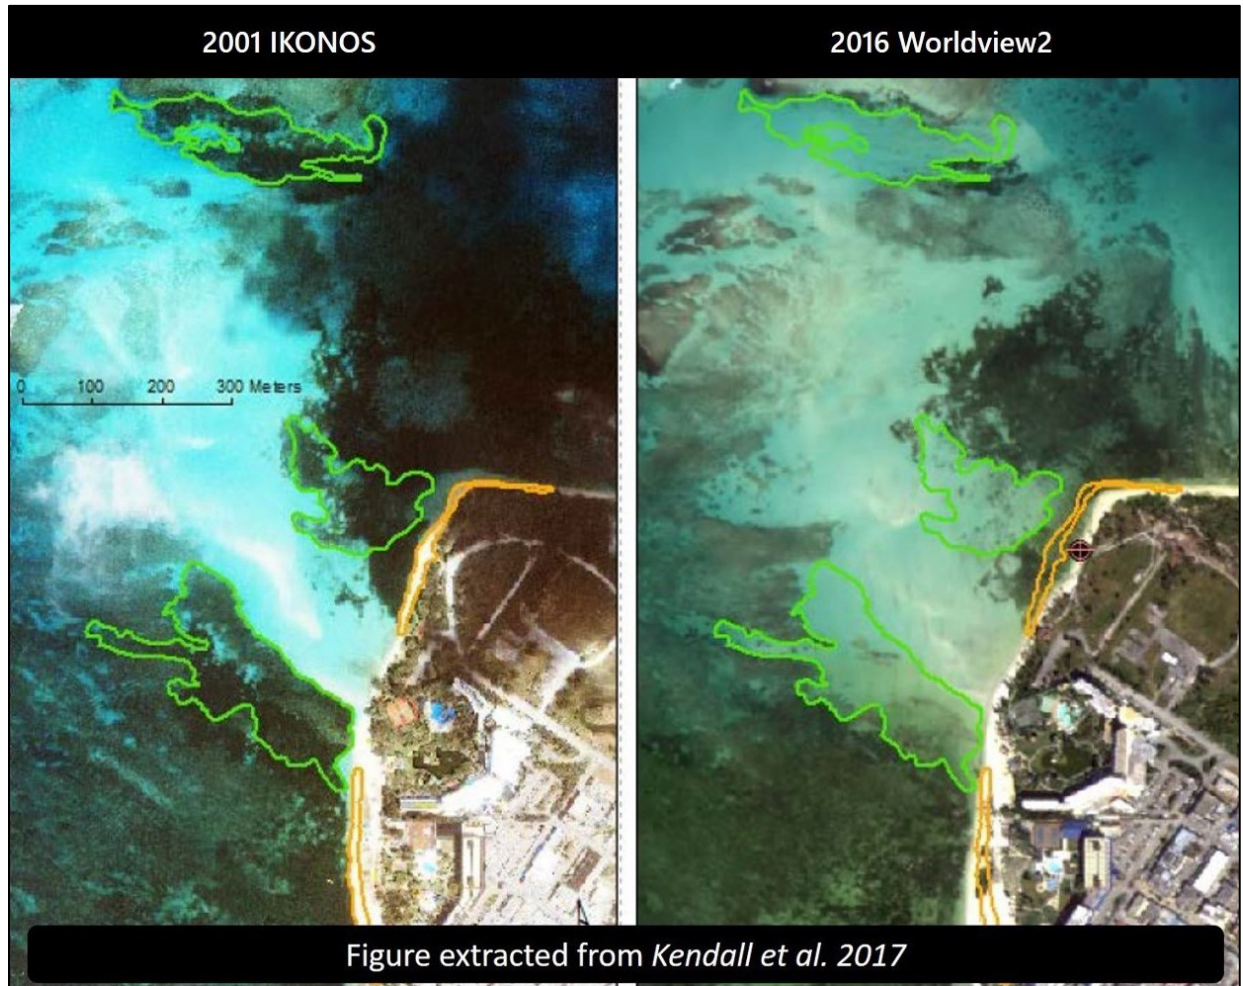
**Figure 35.** Conversion of seagrass meadows to sand-dominated habitat adjacent to American Memorial Park from 2001–2016. Figure extracted from Kendall et al. 2017.

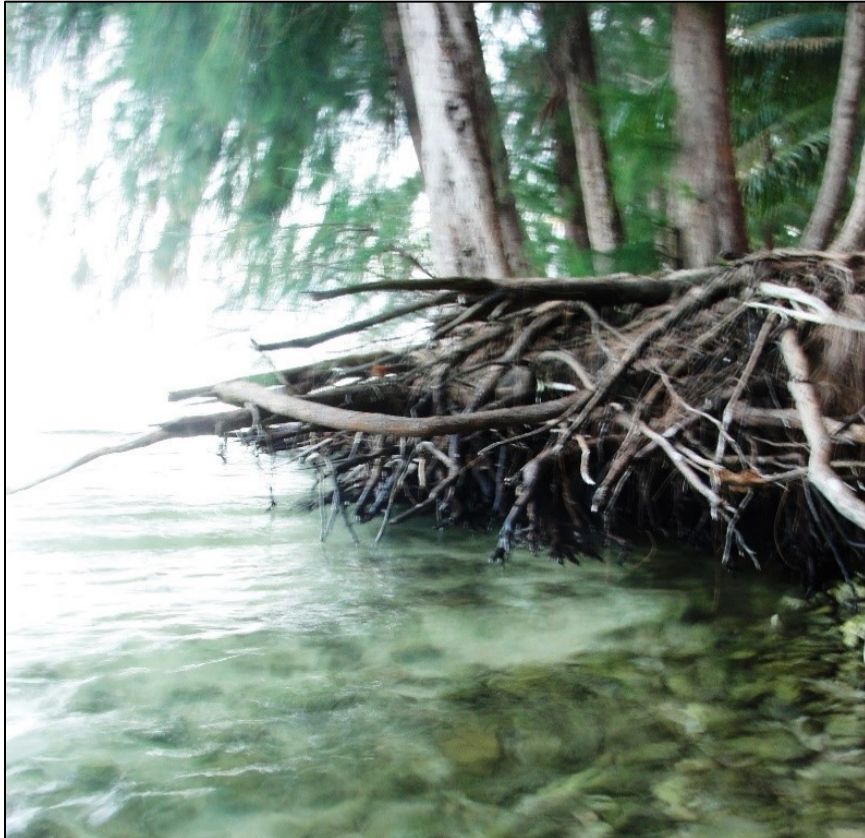
**Figure 43.** A high tide submerges the root systems of ironwood trees at American Memorial Park (Photo by R. Greene 2013).
