Restoration of Impaired Waters from Non-Point Source Pollution in the Kamōhio Watershed on Kahoʻolawe 2023 to 2040

Watershed Plan - 9E

Kahoʻolawe Island Reserve Commission

August 1, 2022

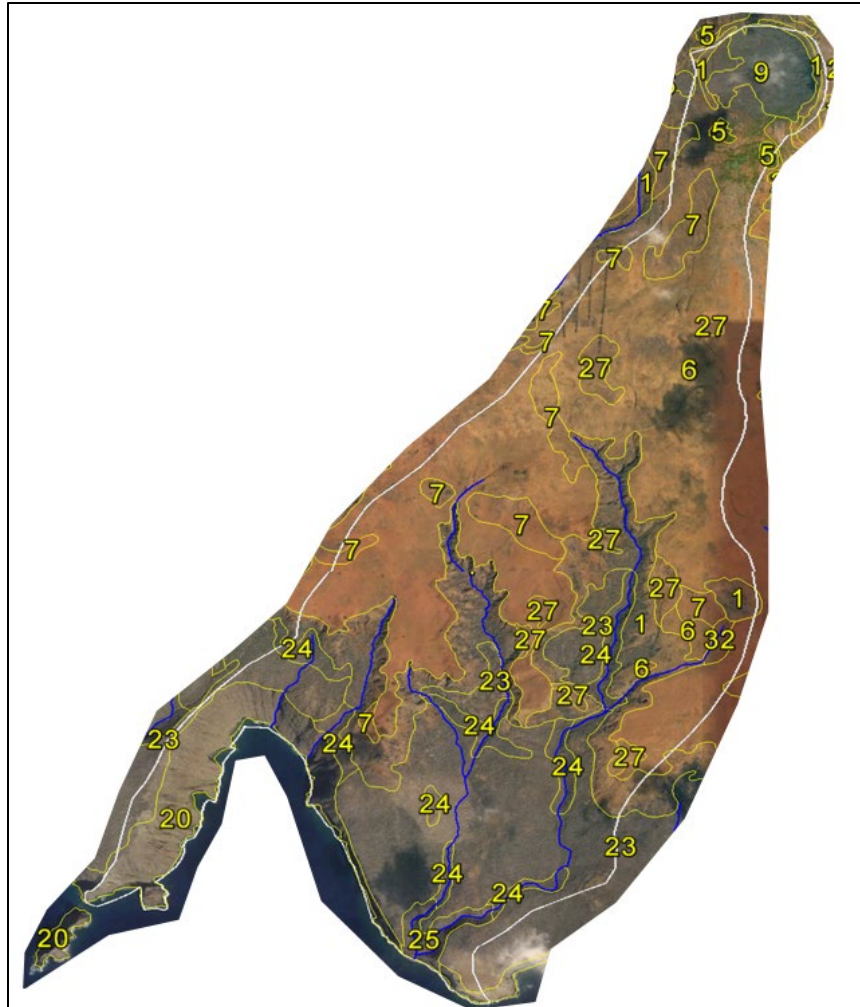
Figure 5 Soil types in Kamōhio Watershed

Soil types in Kamōhio Watershed are listed in Table 2 (USDA, 2011, NCSS, SSURGO, Soil Web network) and shown in Figure 5.

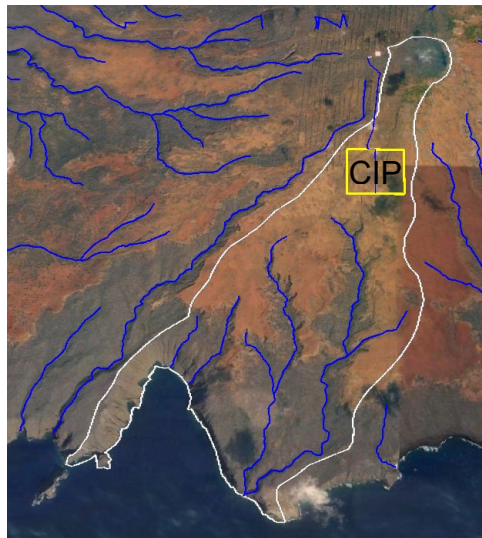
Figure 11 Location of CIP Dryland Forest project outline in Kamōhio Watershed

Figure 11 illustrates the CIP dryland forest project in Kamōhio Watershed.

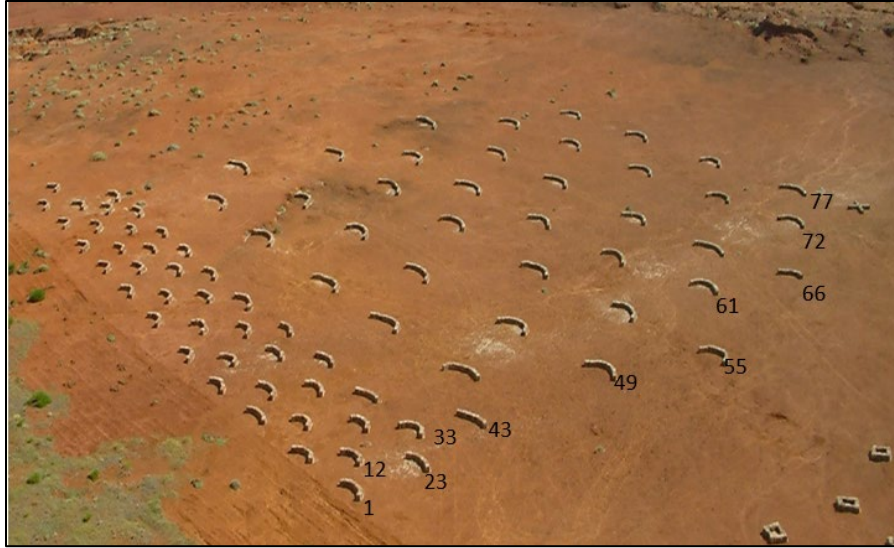
Figure 16 Eighty C-shapes of pili grass (*H. contortus*) bales in Kamōhio Watershed

Many of the native plants from the NHPS IV Project persist today and provide native seed to pili grass (*H. contortus*) bale C-shapes installed by the KIRC in 2003. The pili grass (from Kaho'olawe source material) was grown by USDA Natural Resources Conservation Service (NRCS) in Ho'olehua, Moloka'i. The bales of hay were flown to Kaho'olawe in 2003 and placed in "C shapes" downwind of the NHPS IV area to capture native seed. Figure 16 shows the 80 C-shapes shortly after they were constructed in 2003.

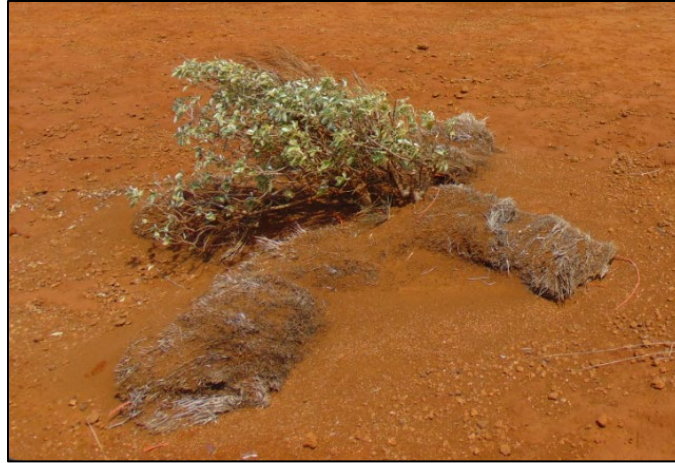
Figure 19 A pili grass kipuka with ewa hinahina (*A. splendens*) in 2019

Constructed in 2010 and seeded with ewa hinahina (*A. splendens*), a native shrub, approximately 40 kipukas were made of pili grass (*H. contortus*) and distributed on the hard pan. Figure 19 illustrates an example of a pili grass kipuka in 2019.

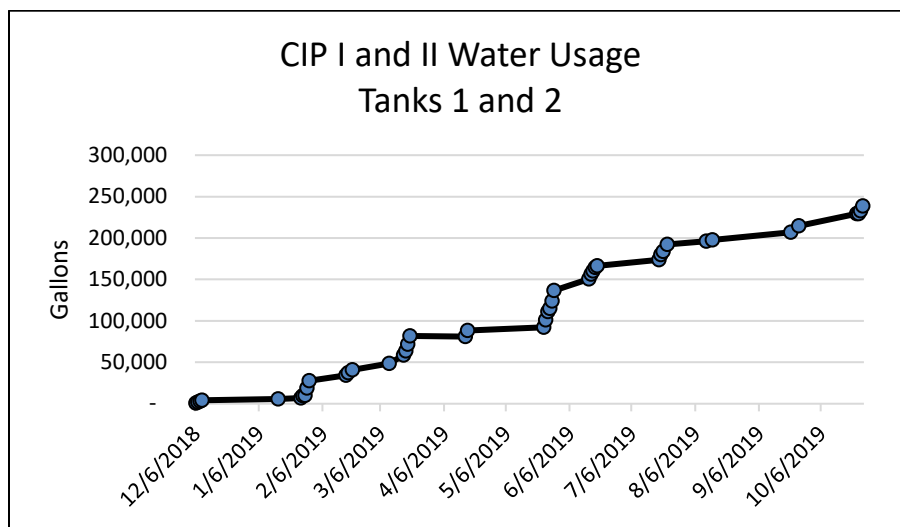
This project was funded by the General Appropriations Act of 2017 and the DLNR Capital Improvement Program (CIP) under Natural and Physical Environment (LNR 906) from the State of Hawai'i. It was entitled "Kaho'olawe Island Reserve Native Dryland Forest Planting and Support". CIP I occurred from 2018 to 2019 and began to establish a dryland native forest with 14,800 native plants on irrigation. Water came through a 1.5" main irrigation line from Tanks 1 and 2, 1.38km (0.86 miles) away. It feeds into 1" sub mains and 3/4" laterals with 1 gallon per hour (gph) pressure compensating emitters. Average water use was 6000 gallons per day (@25 gpm) from December, 2018 to October, 2019 from Tanks 1 and 2 and is illustrated in Figure 20.

Figure 20 Water use in the CIP I and II project

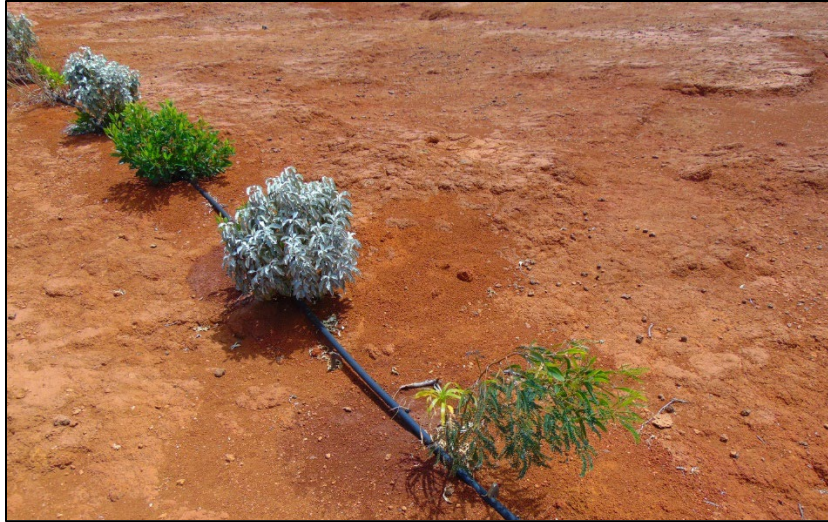
Figure 21 Native plants on irrigation in CIP I

Figure 21 is an example of the native plants in CIP I after 10 months on irrigation.

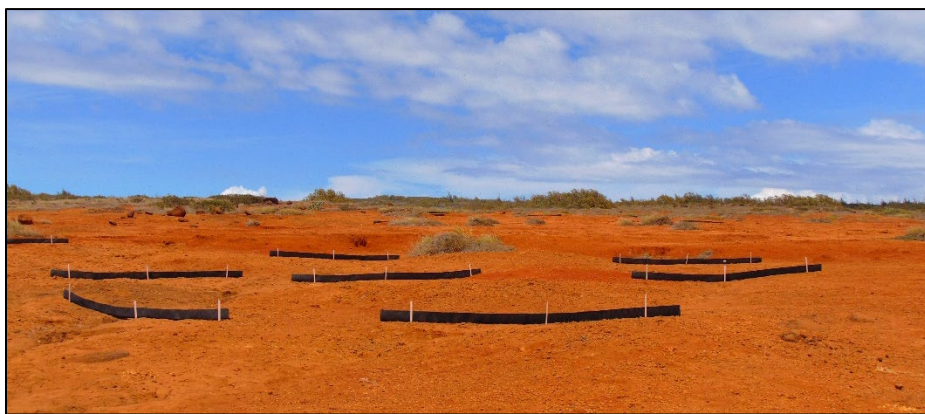
ERTEC Environmental Systems ProWattle™ (Figure 24) is a slope interruption device which spreads and slows water flow rather than concentrate it.

Figure 24 ProWattle™ installed above the CIP Project site in 2019

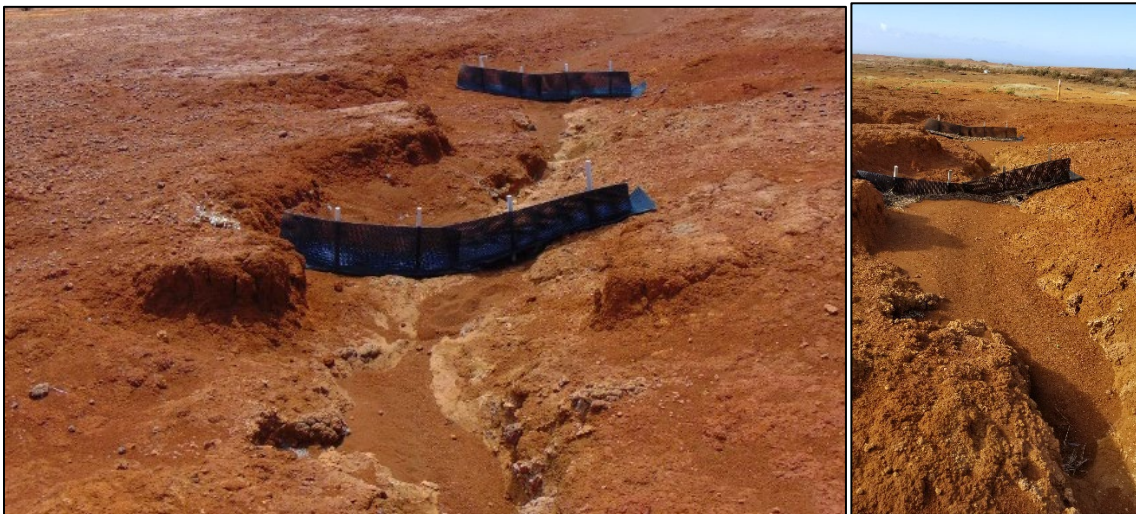
Ditch Guard™ is a water velocity interruption device and acts like a check-dam to slow concentrated flow and downstream erosive energy. Figure 26a, b illustrates the Ditch Guard™ check dams installed above the CIP Project Site in 2019.

Figure 26a, b Ditch Guard™ installation in Kamōhio Watershed

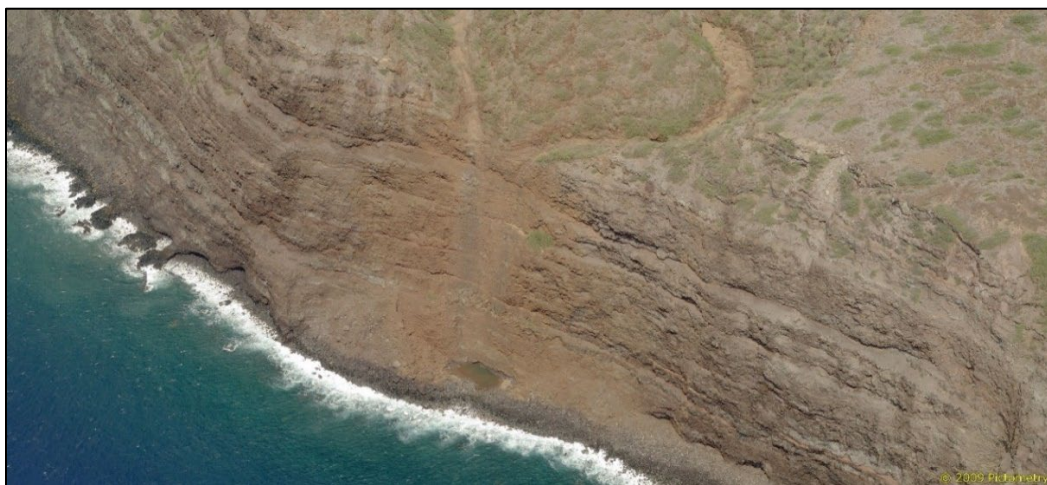
Figure 29 Two main tributaries of Kaneloa stream system meeting at 'Ili'ililoa point on Kaho'olawe

Consisting of two major tributaries that enter the ocean at 'Ili'ililoa point (Figure 29), and two minor tributaries, the Kaneloa stream system is intermittent and collects water from the 886ha (2189A) Watershed only during seasonal rain events.

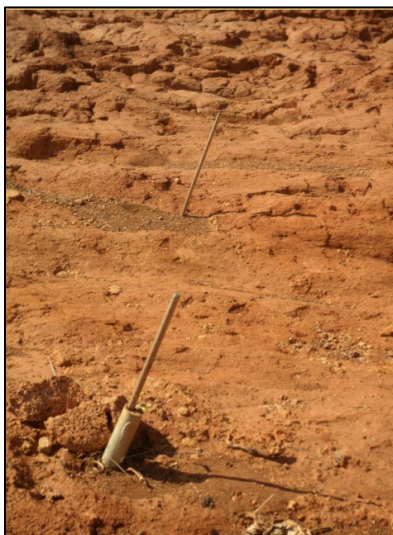
Data for soil erosion pin transects 2 and 3 were not recorded again in 2015. Also, the stainless-steel soil erosion pins (rods) of Transect #7 (Figure 35) were bent in Kaneloa stream bed during a storm event and rendered un-usable.

Figure 35 Bent soil erosion pin transect (#7) rods in Kaneloa stream bed

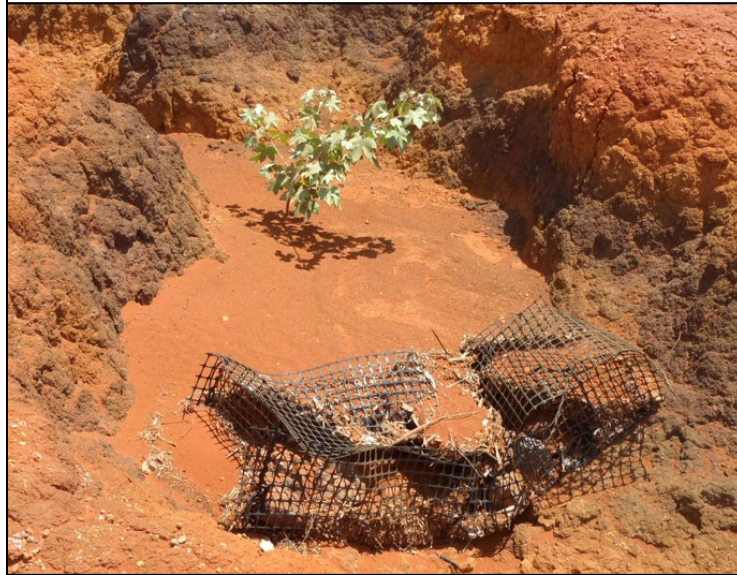
Soil erosion control features such as check dams (gabions and wattles), will be installed throughout the Watershed to reduce the sediment load. These are effective devices in that they allow the passage of water to flow, but retain the sediment that drops out of suspension due to a reduction in velocity of the water. The silt that is captured by a gabion provides excellent substrate for native out plantings off irrigation (Figure 37).

Figure 37 Silt captured behind a gabion with a Hawaiian cotton (Ma'o) plant

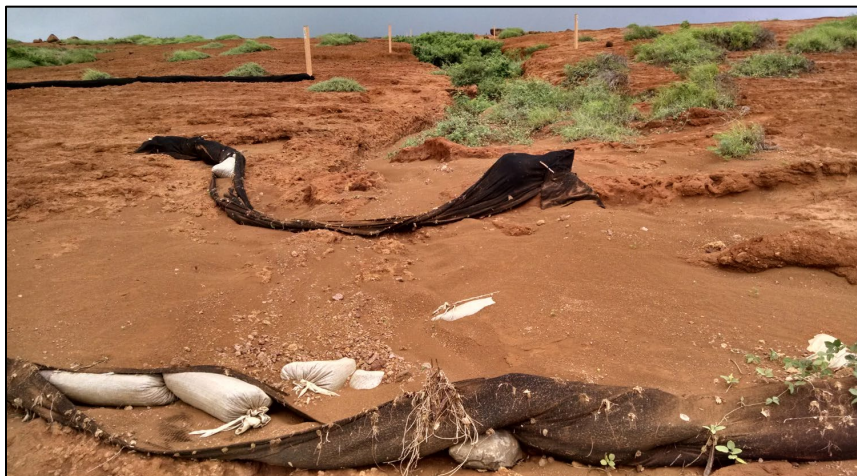
In 2015, a series of geotextile check dams (wattles) were constructed in Kamōhio Watershed but were damaged (and subsequently repaired) after a large storm event (Figure 38).

Figure 38 Check dams installed in 2015 and damaged by a large storm event

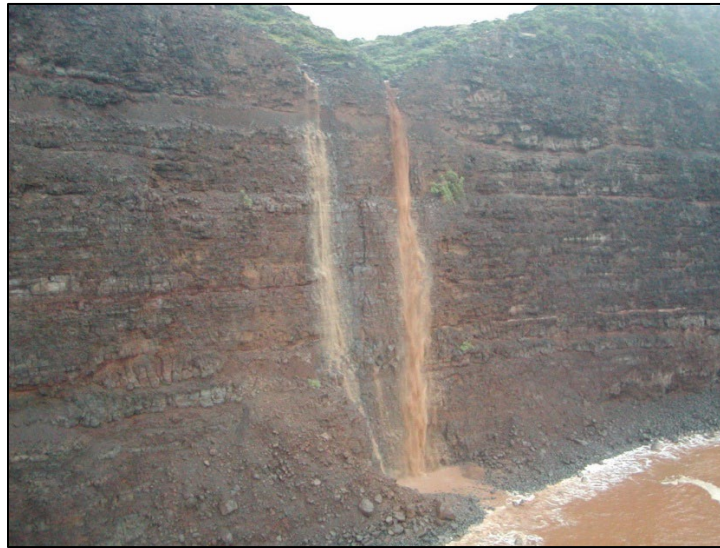
pollutant “Excessive Sedimentation” (Figure 39) enters the near shore ocean waters in Kamōhio Bay.

Figure 39 Sediment entering Kamōhio Bay at ‘Ili‘ililoa point in Kamōhio Watershed

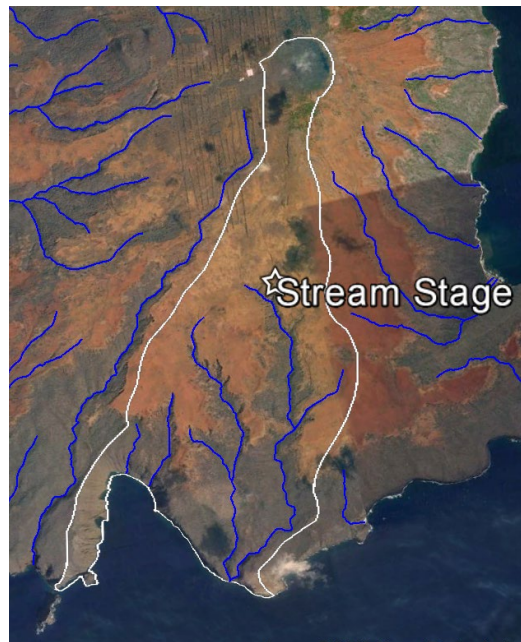
Using a HOBO® water level logger in Kaneloa stream (Figure 41) at 320m elevation (1050 ft) from 12am on 12/11/2015 to 2pm on 2/11/2016, sensor depth data was captured by the University of Hawai'i at Manoa, Department of Civil and Environmental Engineering on December 24, 2015. Approximate UTM (NAD83 4N) location is E 752662, N 2273043.

Figure 41 Location of HOBO® water level logger in Kaneloa stream in Kamōhio Watershed

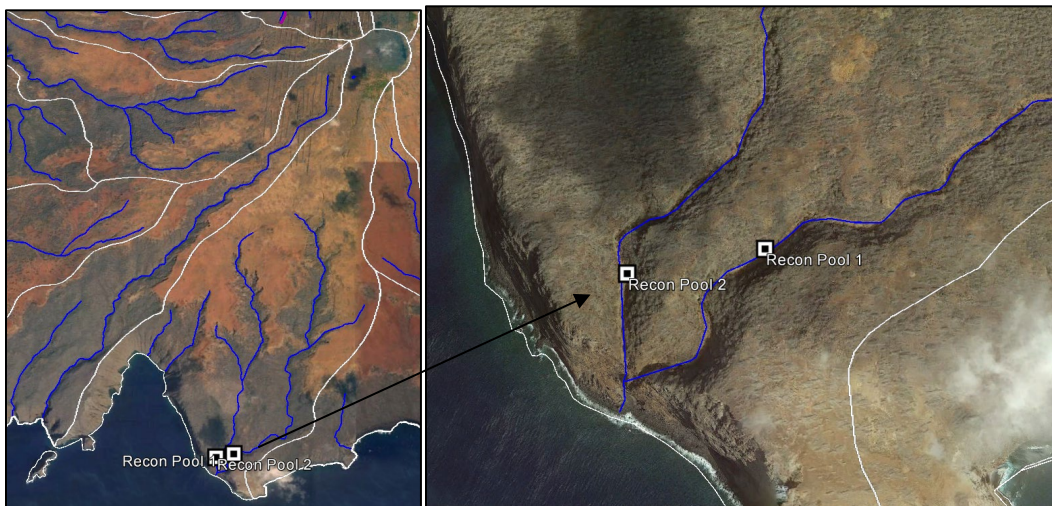
Figure 48a, b Approximate locations of USGS Recon Pools 1 and 2 in Kaneloa Stream

A 1978 USGS sampling data set of two recon pools in the lower reaches of Kaneloa stream provide the earliest water quality data set available. The USGS Recon Pool locations are located by the UTM coordinates on the map in Figure 48a, b.

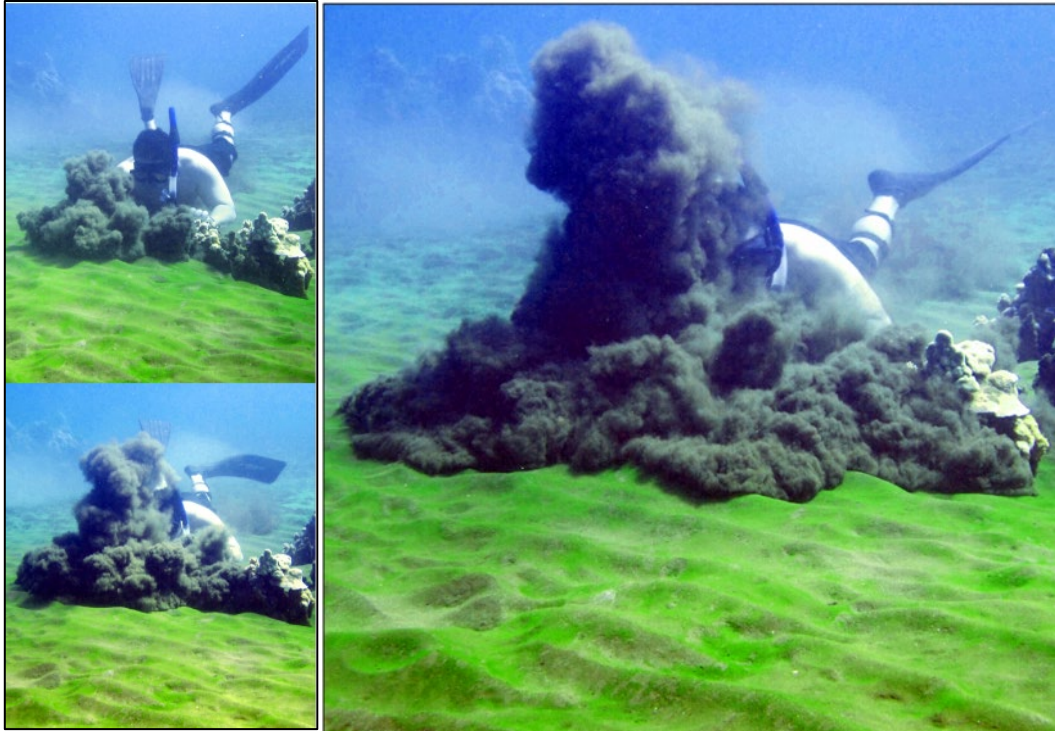
Figure 49a, b, c Residual silt on the near shore ocean bottom

Figure 49a, b and c illustrate the amount of silt that remains on the bottom of the sea floor in the near-shore ocean environment on Kaho’olawe.

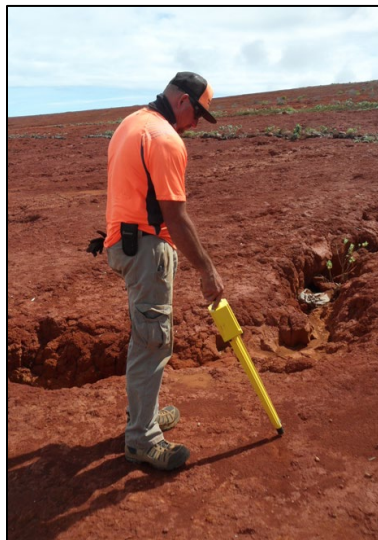
Figure 55 EOD Technician and Schonstedt metal detector on Kaho'olawe

The initial installation of stainless-steel rods of the soil erosion pin transects in Tier I (Surface cleared only) will require an EOD Technician and a Schonstedt metal detector (Figure 55).

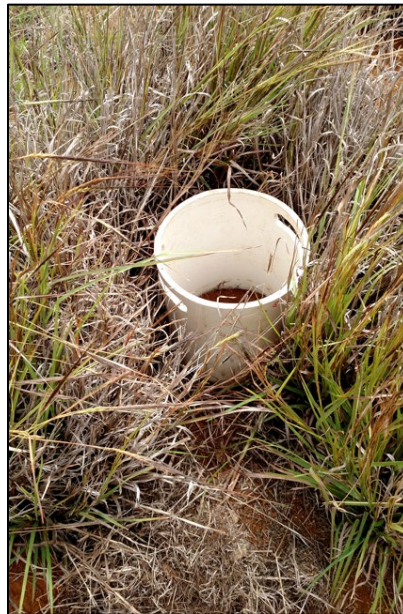
Figure 56 An 8" diameter infiltrometer

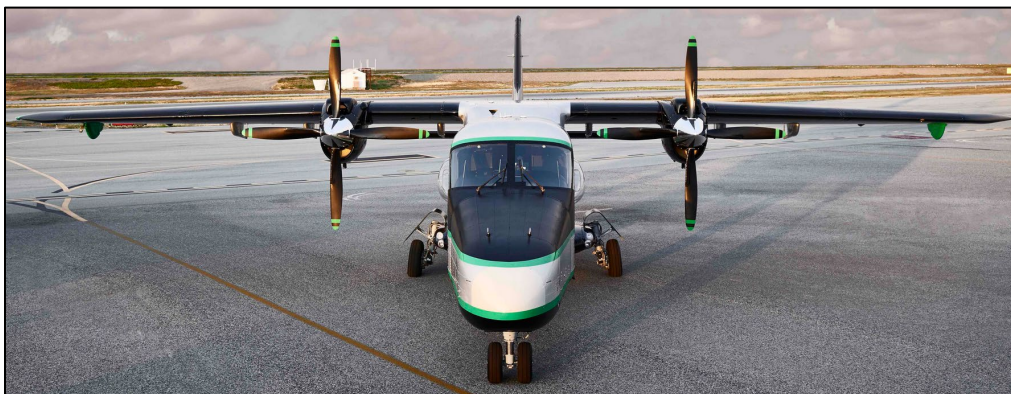
Figure 57 Global Airborne Observatory

A raw and unprocessed (1-meter resolution) Light Detection and Ranging (LiDAR) data set of topography and vegetation height for Kaho'olawe will be acquired by the Global Airborne Observatory (GAO) (Figure 57).

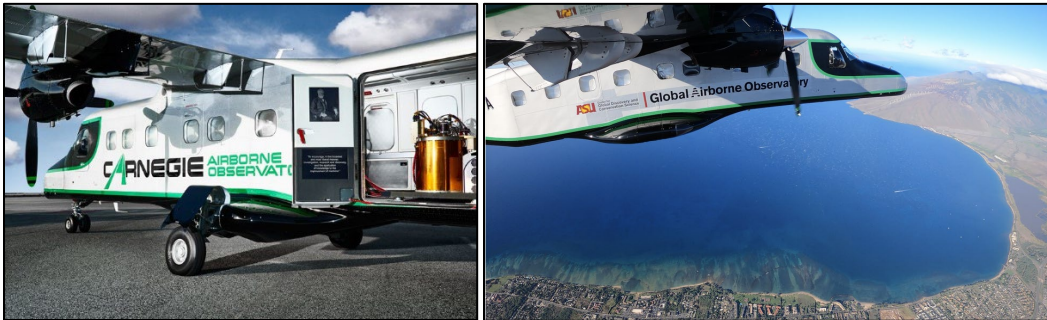
Figure 58a, b Global Airborne Observatory and instruments

Also acquired at this time was multispectral imagery (2-meter resolution) and high resolution (0.5 meter) RGB photography. This data will be processed by Arizona State University and the Global Discovery and Conservation Science personnel to detail the landscape and biomass as well as possibly differentiate between native and non-native plants to produce high resolution species composition maps. Visible-to-Shortwave Infrared (VSWIR) data and Visible-to-Near Infrared (VNIR) imaging spectrometers collected high resolution data. (Figure 58a, b) (<http://asnerlab.org/projects/carnegie-airborne-observatory/>).

The Airborne Taxonomic Mapping System or AToMS has four integrated remote sensing technologies: (i) High fidelity Visible-Shortwave Infrared (VSWIR) Imaging Spectrometer; (ii) Dual-laser, waveform Light Detection and Ranging (wLiDAR) Scanner, (iii) High-resolution Visible-to-Near Infrared (VNIR) Imaging Spectrometer, and (iv) High-resolution Digital Imaging Camera. The VNIR sensor images the chemical content of forests in fine spatial resolution. The VSWIR sensor measures the reflectance of the Earth's surface in 427 channels from the ultraviolet through the visible near-infrared and short-wave infrared, allowing it to measure the chemicals in the environment, such as tree canopies, in fine spectral resolution. Interior of the GAO and sensors are presented in Figures 59a, b (<https://gao.asu.edu/building-cao>).

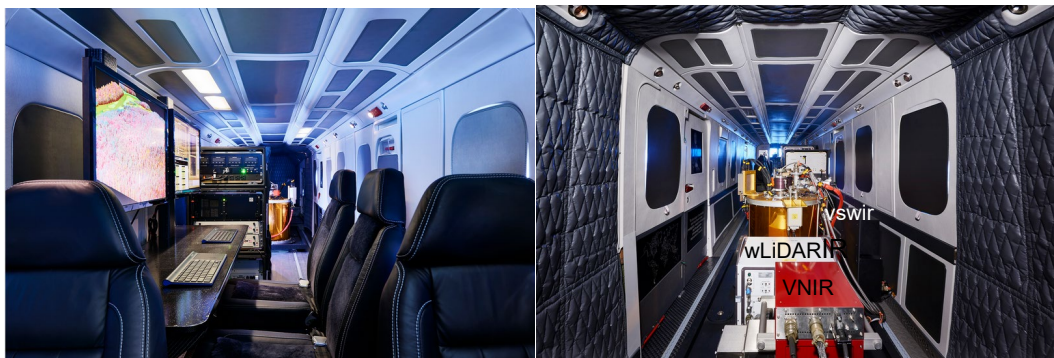
Figure 59a, b Interior of GAO and sensors

The VNIR sensor (red box) measures the chemical content of forests (fine spatial resolution) while the VSWIR sensor (gold cylinder) measures the chemical content of forests (fine spectral resolution). The wLiDAR sensor (white box) maps the geometry of the forest by measuring the structure below treetops, branches and to the ground.

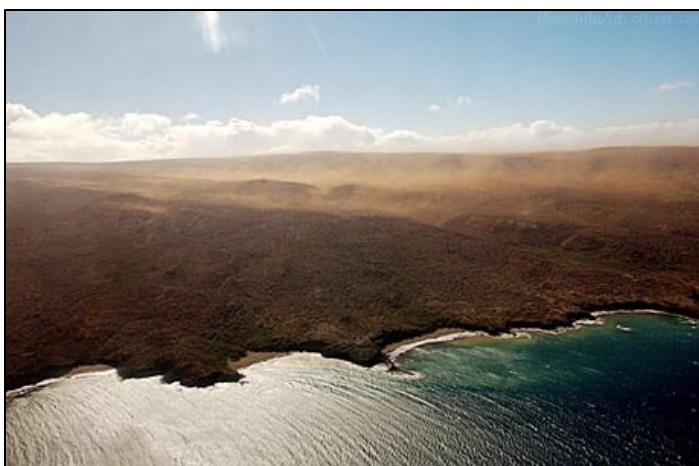
Surface runoff on Kaho'olawe is estimated at 7×10^7 m³ (19 billion gallons) per year (Cox et al., 1995). Dike impounded groundwater system may hold between 21-86 billion gallons of water (County of Maui, 1990). Soil is lost through surface runoff into the ocean causing dense plumes of turbidity. During the period between October and March, there may be three or as many as seven major storm events in any particular year, and these storms may bring heavy rains and are sometimes accompanied by strong 50 mph winds at least on a local scale.

Windblown soils November 11, 2003

On the open hardpan, wind is the most significant factor preventing revegetation (KERP, 1998).

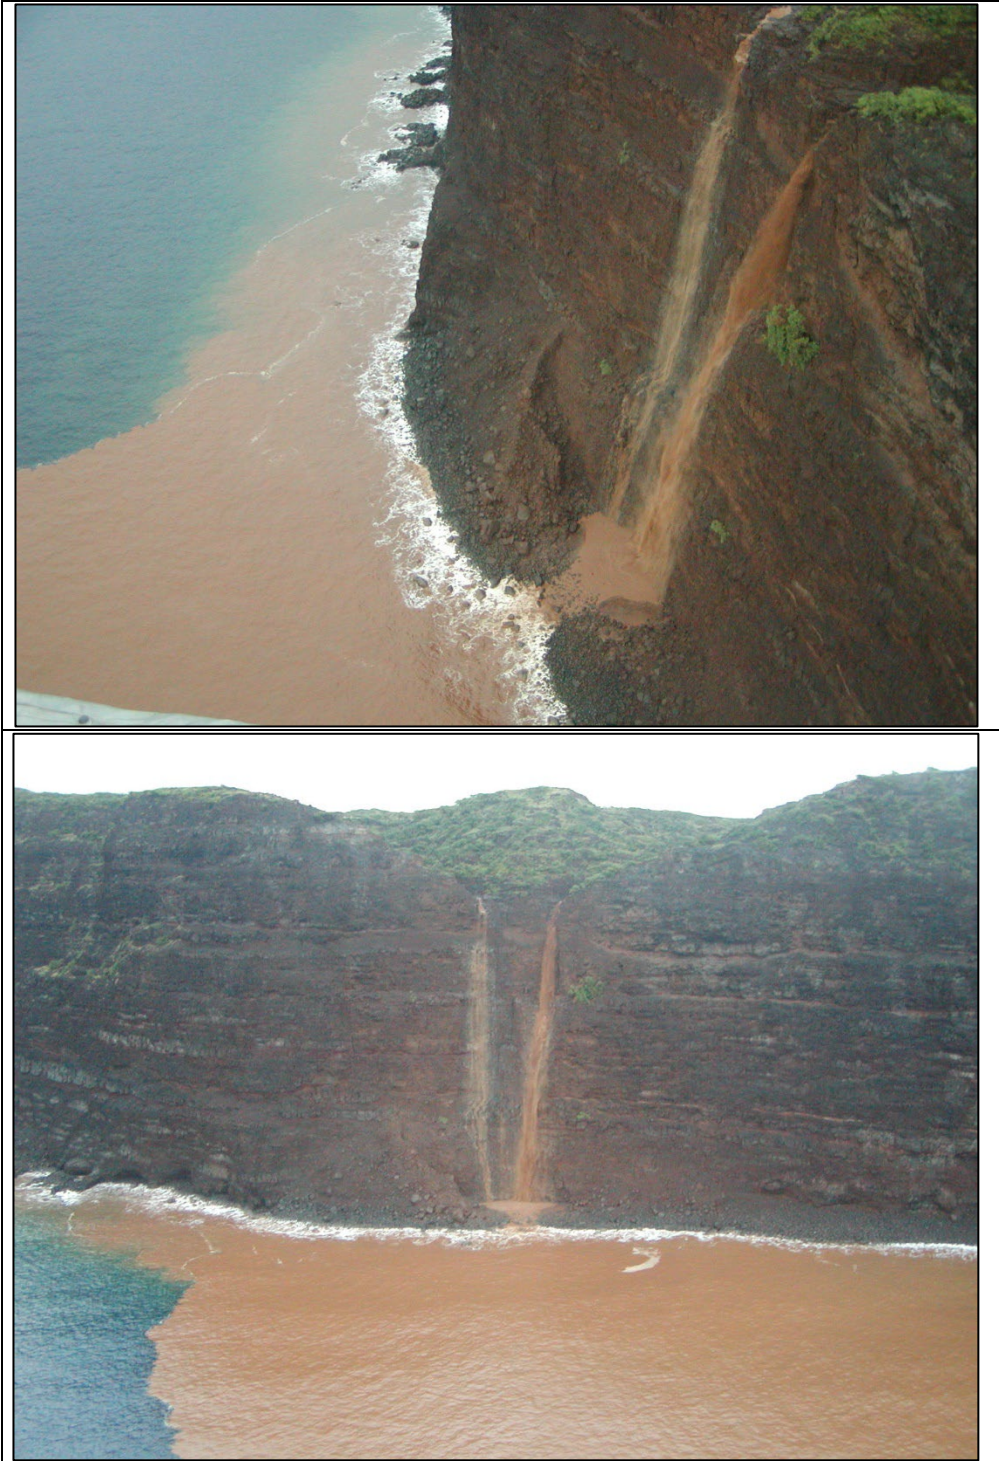
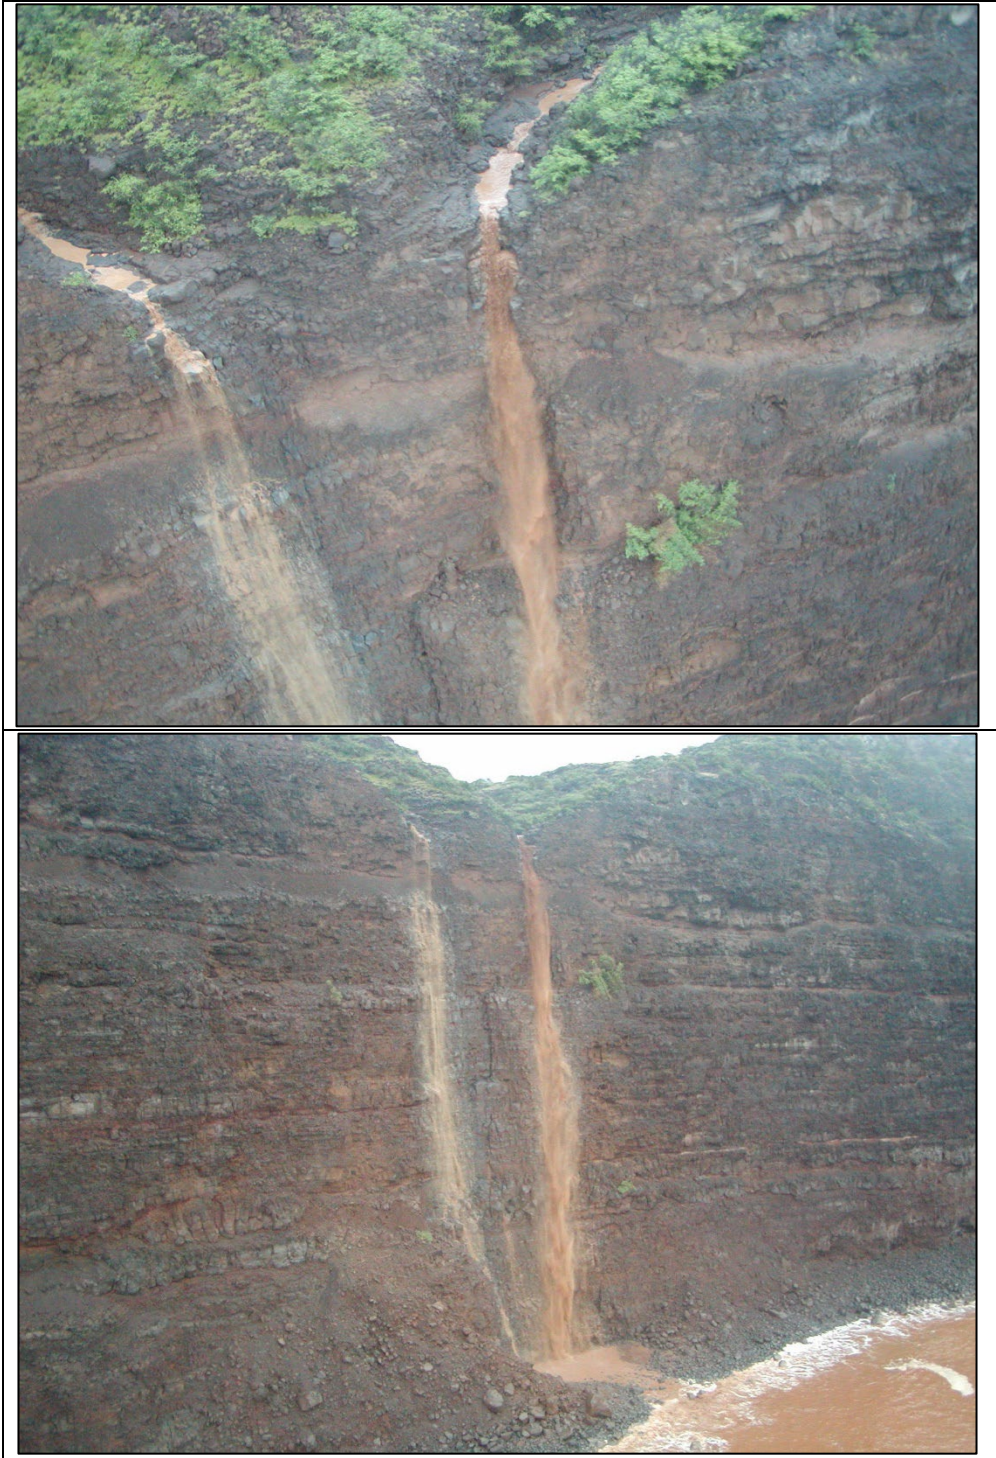
Photos from February 2005 'Ili'ililoa Pt in Kamōhio Watershed

At times of stream flow, these two minor and two main tributaries distribute tons of sediment into the near shore ocean environment causing turbidity plumes (Appendix C). Figure 30 illustrates the two minor stream tributaries (A and B) in Kamōhio Watershed entering Kamōhio Bay.
